Exterior Decay of Wood–Plastic Composite Boards: Characterization and Magnetic Resonance Imaging

Forest Prod. J. 66(1/2):4–17.

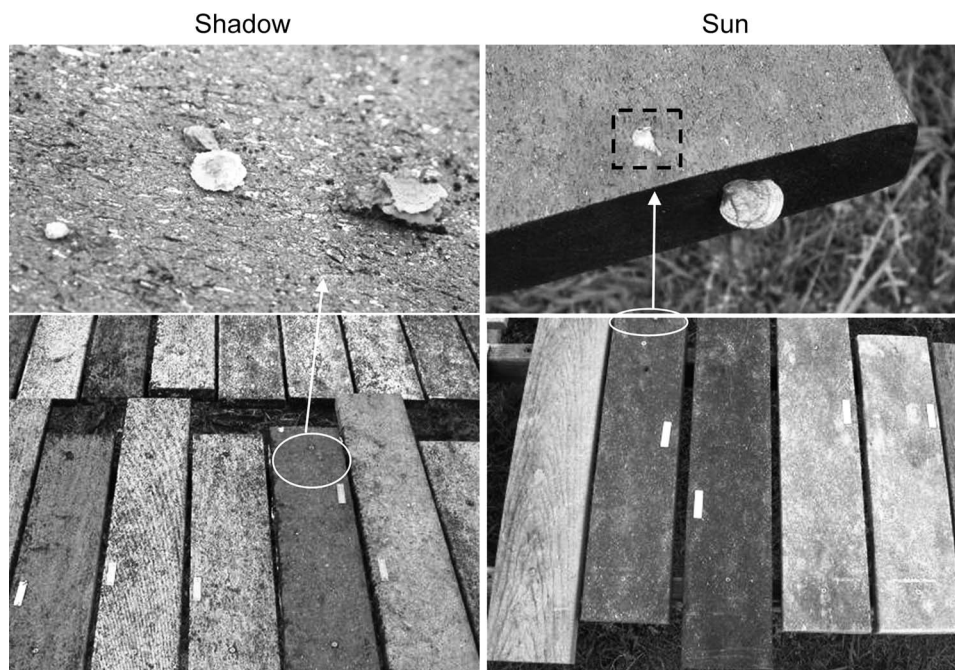
Figure 3.—Shadow (left) and sun (right) boards exposed at their respective locations in 2009, after 51 months of exposure. Areas of interest containing fungi fruiting bodies are marked with circular annotations; an example of a composite defect is enclosed in the dotted lines.

After 28 months of field exposure (in 2007), the shadow and sun boards showed no obvious signs of fungal growth. However, periodic field inspections after 40 months showed a single fruiting body of a decay fungus on the board at the sun location. Further inspection a year later showed several fruiting bodies on boards exposed in both sun and shadow locations. Additional fruiting bodies were observed with increasing exposure time. Figure 3 shows the shadow and sun boards in 2009 (51 mo of exposure) with visible fruiting bodies. This was the last inspection of the boards before their collection for evaluation in 2012. Some of the fruiting bodies visible on the surface of the boards after 8 years of exposure (November 2012) were photographed just before the detailed examinations described in this article (Figs. 4 and 5). The boards maintained their integrity, and wood particles were still visible in the cross sections despite the extensive decay detected from the density loss between reference and exposed samples, as described in the next section.

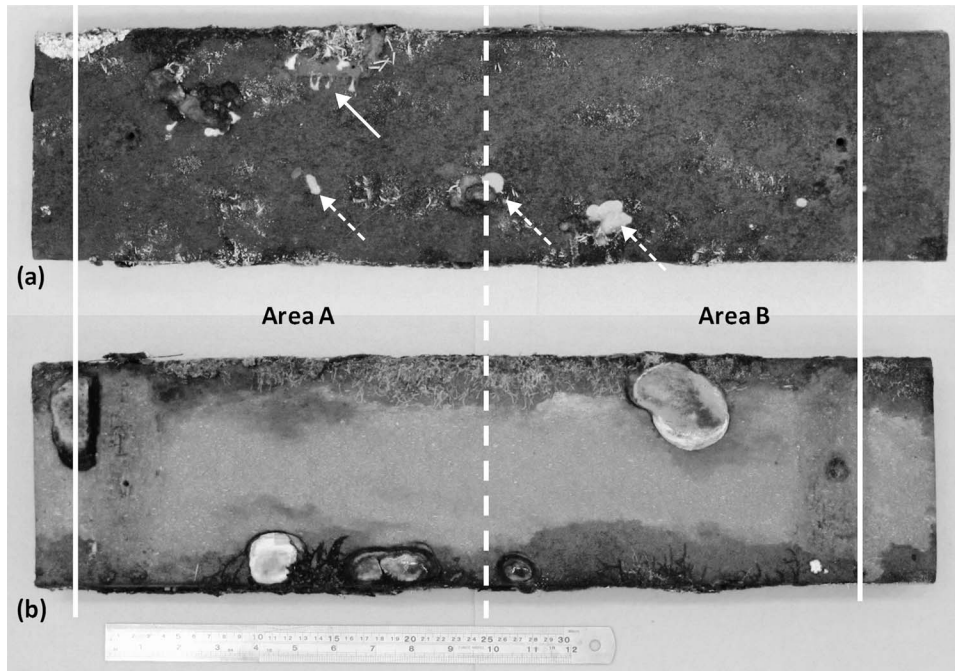
Figure 4.—Shadow board (a) top (exposed) side and (b) bottom side after 51 months of exposure, where the dotted line shows the division between areas A and B, which were imaged separately due to the limitation of the magnetic resonance imaging equipment. The arrow with the solid line points to *Dacryopinax spathularia*, a jelly fungus that causes brown-rot; the arrows with dashed lines point to fruiting bodies of a polypore, tentatively identified as *Pycnoporus sanguineus*, a white-rot fungus.

At least six different species of wood-inhabiting fungi were fruiting on the boards. The bright yellow fruiting bodies (Fig. 4a) are *Dacryopinax spathularia*, a jelly fungus that causes brown-rot. It is a common fungus in Hawaii (Hemmes and Desjardin 2002) and is frequently associated with plywood, 2 by 4s, lanai railings, or any other wood that is wet. The other fungi could not be definitively identified to species because of the lack of basidiospores in the dried samples. The red fruiting bodies in Figures 4a and 5a are tentatively identified as the polypore *Pycnoporus sanguineus*, a white-rot fungus that is one of the most common shelf polypores in Hawaii (Hemmes and Desjardin 2002), where it is commonly found on stumps and fallen logs and branches. The green fruiting body shown in Figure 5a is most likely a species of the genus *Chlorociboria*, a staining fungus that does not cause significant decay. Other fungi shown in Figures 4b and 5b may include species within the white-rot genera *Phellinus* and possibly *Ganoderma*; identification to species was not possible owing to the extensive degeneration of the old fruiting bodies. Several small, thin fruiting bodies were also observed; these were sterile and could not be identified to genus. The material supports a wide variety of wood-inhabiting fungi, many of which can cause decay.

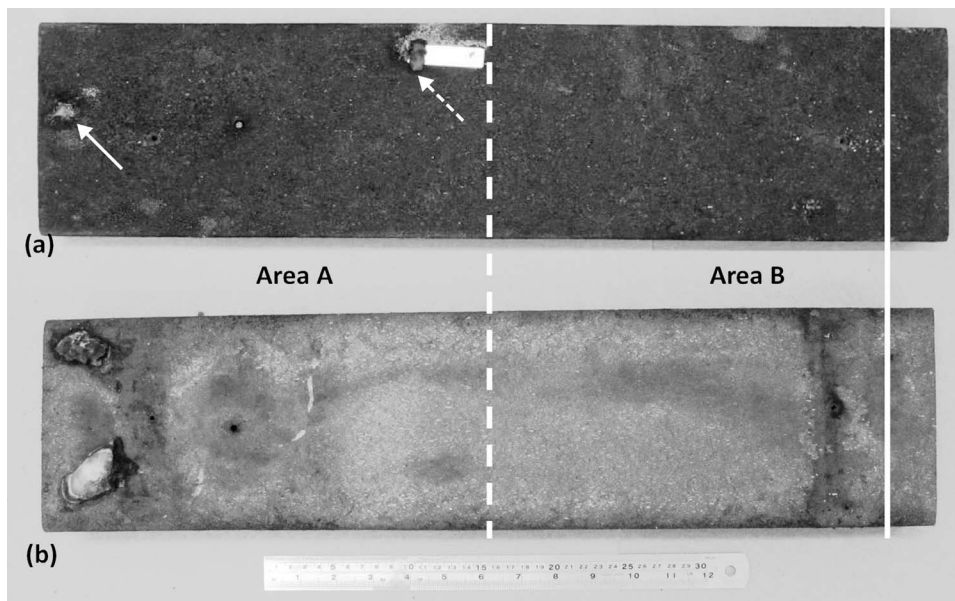
Figure 5.—Sun board (a) top (exposed) side and (b) bottom side after 51 months of exposure, where the dotted line shows the division between areas A and B, which were imaged separately due to the limitation of the magnetic resonance imaging equipment. The arrow with a dashed line points to fruiting bodies of a polypore, tentatively identified as *Pycnoporus sanguineus*, a white-rot fungus; the arrow with a solid line points to fruiting bodies of *Chlorociboria* sp., a stain fungus.

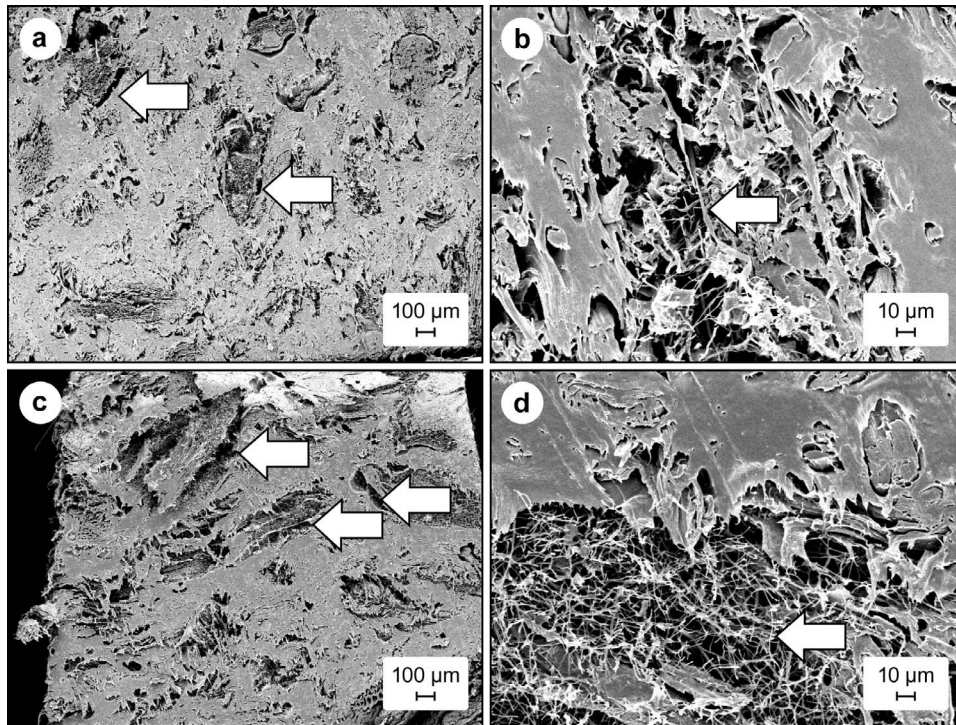
Figure 7.—(a) Scanning electron microscopy (SEM) image taken from Location 5 of the sun sample collected in 2012 (ovendried density of 0.67 g/cm^3). Some areas appear intact, whereas other areas contain masses of hyphae (white arrows). (b) Higher magnification near the center of the same sample (ovendried density of 0.67 g/cm^3) showing a wood particle colonized by fungi with evidence of white-rot decay, including breakdown of cell wall integrity, leading to the formation of a small void (white arrow). (c) SEM image of the same sample (ovendried density of 0.67 g/cm^3) showing voids forming around wood particles from degradation caused by white-rot fungi (white arrows). (d) Higher magnification near the center of image (c).

SEM images revealed significant decay in sun and shadow samples collected in 2012, which had lower ovendried densities (Figs. 7 and 8). Wood cell walls with severe levels of decay could be observed. The sun sample

collected in 2012 corresponding to Location 5 (Table 2) and an oven-dried density of 0.67 g/cm^3 (Fig. 7) had some relatively sound areas but also areas where masses of fungal hyphae were surrounding the wood particles, causing severe decay resulting in void formation. The 2012 shadow sample at Location 5 (0.60 g/cm^3) had some areas of severe decay (Fig. 8) resulting in voids packed with white-rot fungi (Fig. 8b).

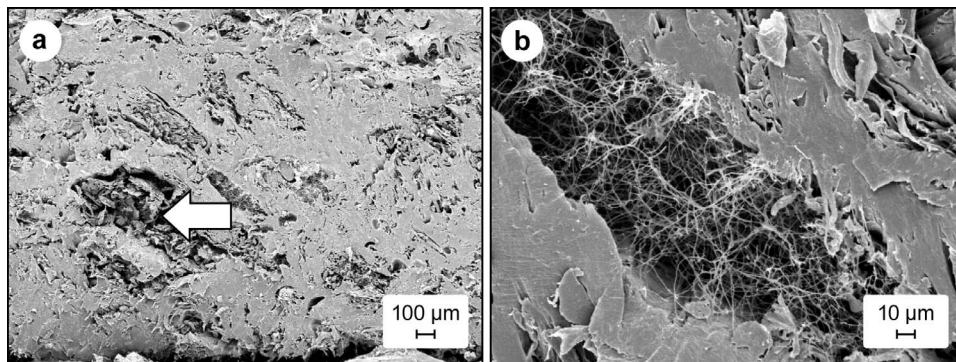
Figure 8.—(a) Scanning electron microscopy (SEM) image of taken from Location 5 of the shadow sample collected in 2012 (ovendried density of 0.60 g/cm^3). Large voids are forming in the sample where wood cell walls have degraded to the point of collapse of structure (white arrow). (b) Higher magnification SEM image near the center of the same sample (ovendried density of 0.60 g/cm^3). Voids have formed where the wood component has been completely degraded, leaving a mass of hyphae occupying the space created.

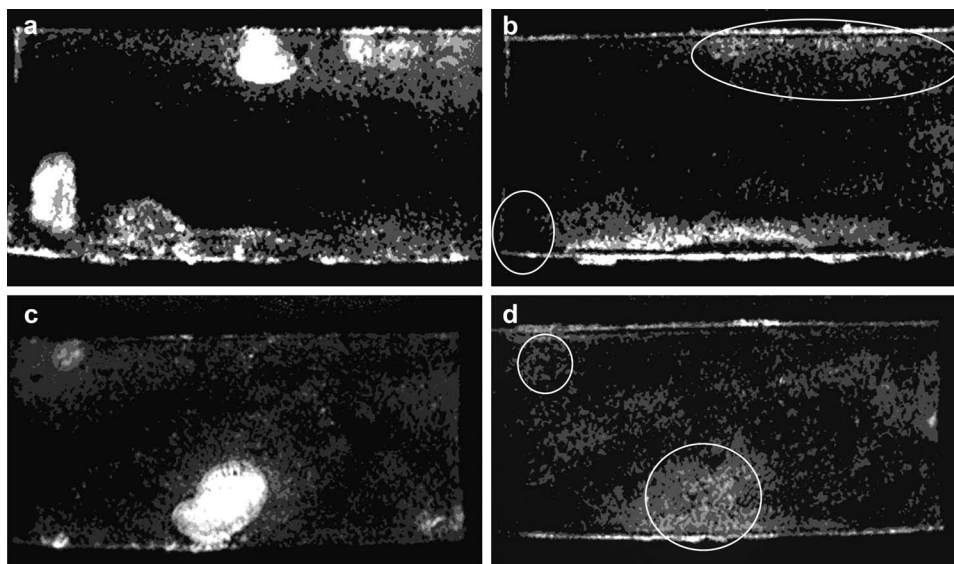
Figure 9.—Magnetic resonance images of the shadow board obtained in Plane 1 at (a) Side A showing the slice at the bottom surface of the board, (b) Side A showing the slice about 8 mm above the bottom surface of the board, (c) Side B showing the slice at the bottom surface of the board, and (d) Side B showing the slice about 8 mm above the bottom surface of the board. Images (a) and (c) mirror the bottom side of the board shown in Figure 4b.

shown in Figure 9. Fungal fruiting bodies, which appear as relatively bright white ovular features, indicating a high concentration of free water, are apparent in images obtained at the very bottom surface of the board. Figure 9a, an image obtained in Plane 1 of the bottom of Side A, shows the presence of free water associated with three fungal fruiting bodies, which were previously seen in Figure 4b. In the same area, another image obtained in the same plane 4 mm above the bottom surface of the board shows that in the vicinity of two of the three fungal fruiting bodies, there is an increase in localized moisture, as indicated by gray regions along the top edge of the image (Fig. 9b). However, there is an obvious lack of free water in the bottom left corner of the image, in an area directly adjacent to the third fungal fruiting body. Figure 9c shows an image obtained in Plane 1 of the bottom of Side B of the board, again displaying the moisture-abundant fruiting bodies present. An MRI slice obtained 4 mm above this area indicates the significant presence of free water throughout the greater portion of the

imaged area, and in particular, at both locations immediately adjacent to fungal fruiting bodies (Fig. 9d).

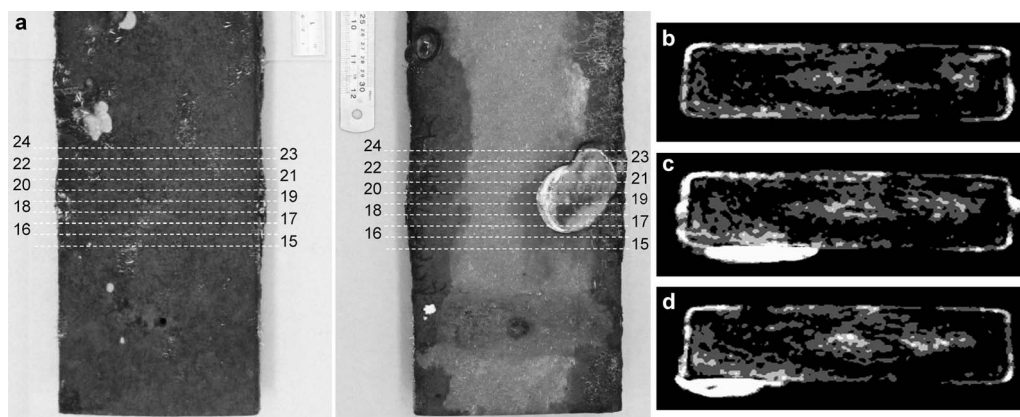
Figure 10.—Images of the shadow board at Side B of the board in the vicinity of a fungal fruiting body showing the location of the slices (a) and magnetic resonance images obtained in Plane 2 of (b) Slice 15, (c) Slice 19, and (d) Slice 23.

Cross-sectional MRI images were obtained in Plane 2 at the location of various fungal fruiting bodies. Figure 10 shows a fruiting body at Side B of the shadow board along with accompanying images obtained in this area. Figure 10b first shows a cross-sectional slice obtained in Plane 2 just to the right of the fruiting body, with low to moderate moisture above the fiber saturation point present at the bottom left corner of the slice. In contrast, Figures 10c and 10d display significantly higher MC in the same area now directly adjacent to a fungal fruiting body, indicated by the bright white feature. In all three images, a significant amount of free water is visible in the core of the samples.

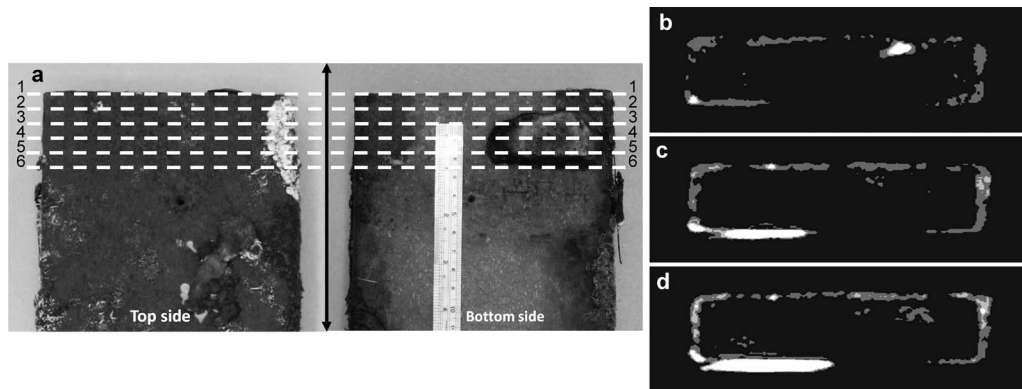
Figure 11.—Images of the shadow board at Side A of the board in the vicinity of a fungal fruiting body showing the location of the slices (a) and magnetic resonance images obtained in Plane 2 of (b) Slice 2, (c) Slice 3, and (d) Slice 4. It should be noted that the bottom side image shown was obtained by flipping the board along the longitudinal axis indicated by the black arrowed line in (a).

It was found that not all instances of fungal fruiting body presence were accompanied by an increase of localized MC in the area. Cross-section images obtained in the vicinity of a fungal fruiting body at Side A of the shadow board showed little to no free water in the WPC board directly adjacent to the fruiting body, which appears as a bright white feature at the bottom left of the image (Fig. 11).

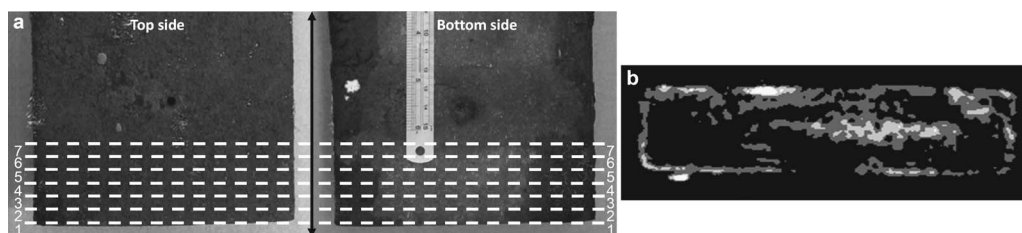
with only a gray border of moisture along the board surfaces (Figs. 11b through 11d), there were many other cases where a significant amount of water was detected at the core of the samples. Figure 12 shows an image obtained in Plane 2 of the shadow board at Side B, approximately 192 mm from the edge (Slice 7). Aside from a thin moisture-rich border around the surface of the sample, the moisture gradient in this board segment appears to be from within the core of the board to the outside. The pattern and geometry of areas containing free water are very variable in this board segment and are difficult to explain based on the expected mechanism of diffusion related to mass transfer from the exterior environment. This suggests that water generated by the decay process likely plays a significant role in the moisture distribution observed, as discussed later in this section.

Figure 12.—Images of the shadow board at Side B of the board showing (a) the location of the slices and (b) magnetic resonance image obtained in Plane 2 of Slice 7. It should be noted that the bottom side image shown was obtained by flipping the board along the longitudinal axis indicated by the black arrowed line in (a).

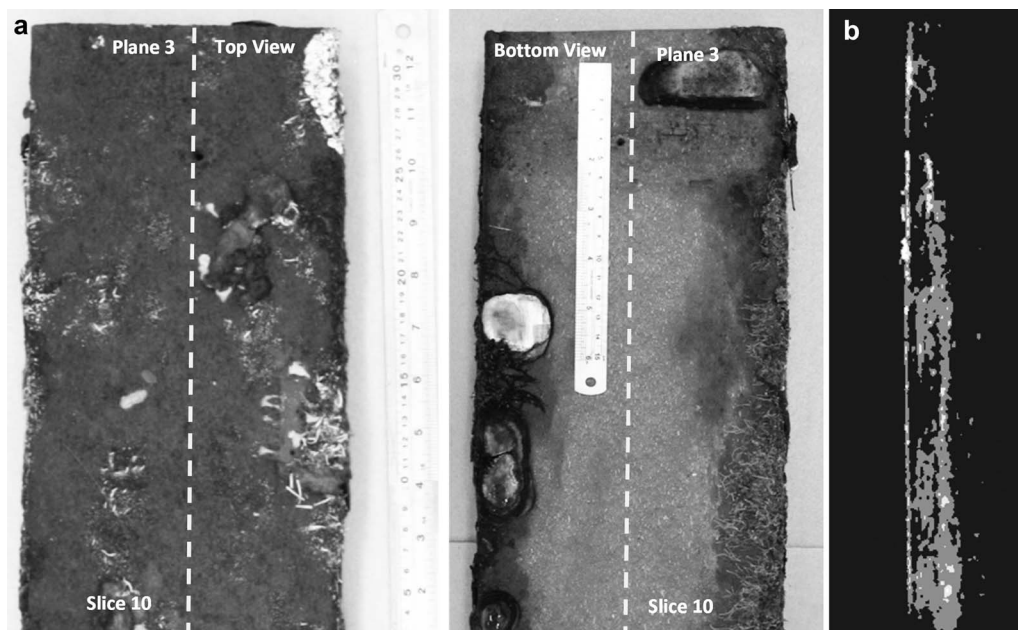
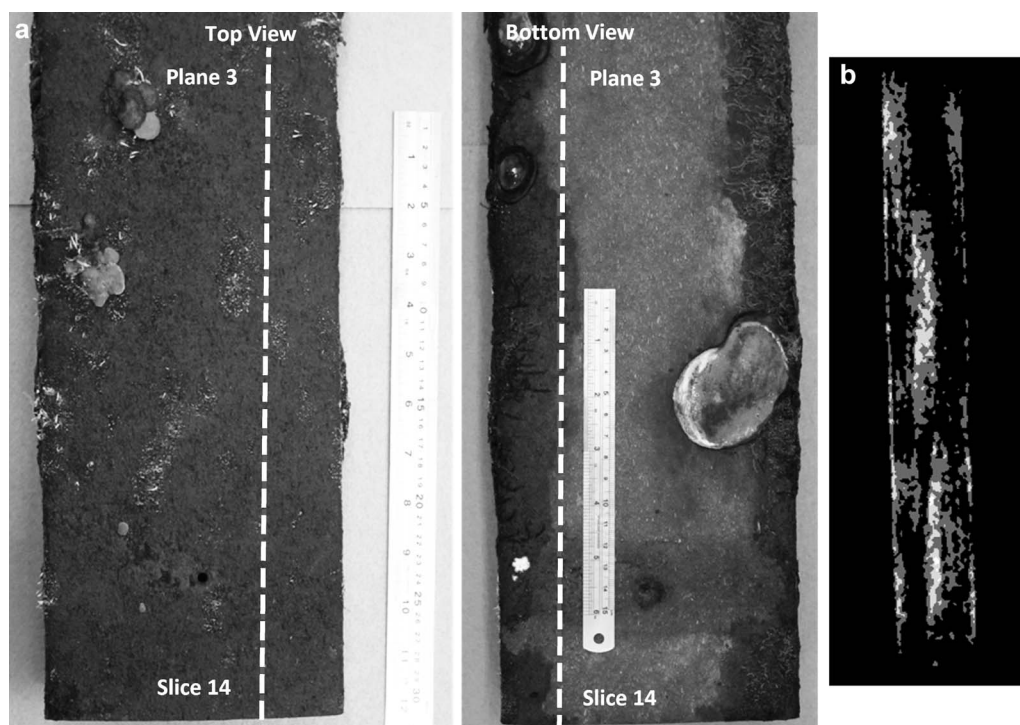
A similar pattern of free moisture distribution was also observed in images obtained in Plane 3 of the shadow board segment from both Side A and Side B (Figs. 13 and 14). In both images, a clear moisture-rich layer surrounding the surface of the samples is apparent, as is a significant reverse moisture gradient originating from the core of the cross section.

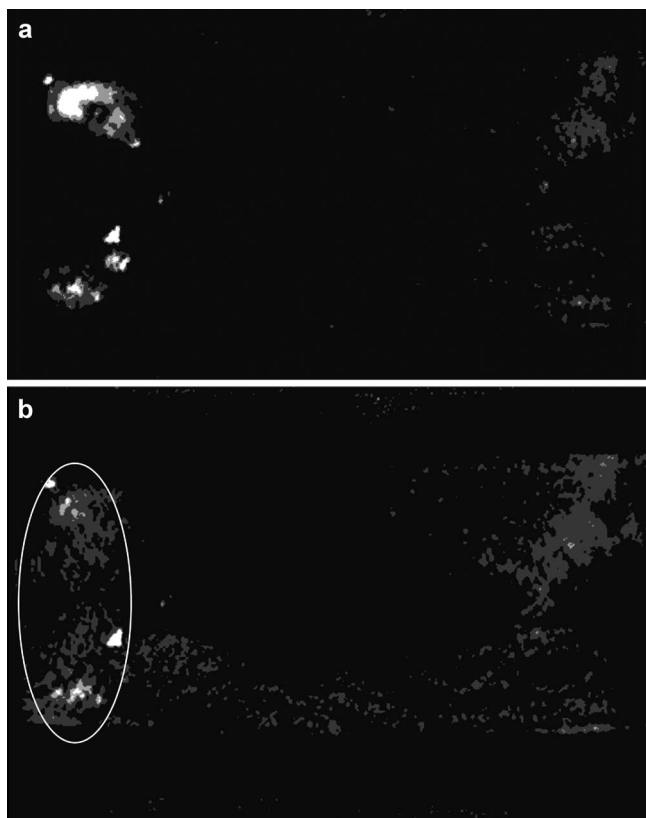
Board segment exposed in sun.—MRI images of the sun board were obtained in Plane 1 from Side A of the board corresponding to Figure 5b. Fungal fruiting bodies present at the bottom of the board can clearly be seen in the images as brighter areas (Fig. 15a). As could be expected, the fungal fruiting bodies contain a relatively large quantity of free water and are easily identified in the images. An image obtained 4 mm above the bottom surface of the board also showed the concentration of free water, in the form of gray

areas, in the vicinity of where the fungal fruiting bodies were located (Fig. 15b).

Figure 15.—Magnetic resonance images of the sun board obtained in Plane 1 at Side A showing (a) the slice at the bottom surface of the board and (b) the slice 4 mm above the bottom surface of the board. These images mirror the image of the bottom side of the board shown in Figure 5b.

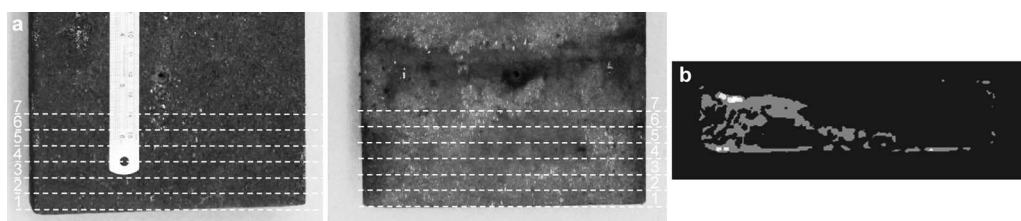
For the board segment exposed in sun, images of the sample cross sections often appeared without the typical light-colored border, indicating a high MC near the surface but a relatively high free water concentration in their core. Figure 16 shows an example of this phenomenon where an image was obtained in Plane 2 of the sun board at Side B,

approximately 32 mm from the edge of the board (Slice 4). Another example of this phenomenon can be observed in Figure 17, which shows an image obtained in Plane 3, Side A of the same board, approximately 32 mm from the longitudinal edge on the left-hand side based on the top view of the board. There appears to be a lack of a thin moisture-rich layer at the outer exposed surface of the sample, which is on the left-hand side of the image.

Figure 16.—Images of the sun board at Side B of the board showing (a) location of the slices and (b) magnetic resonance image obtained in Plane 2 of Slice 4.

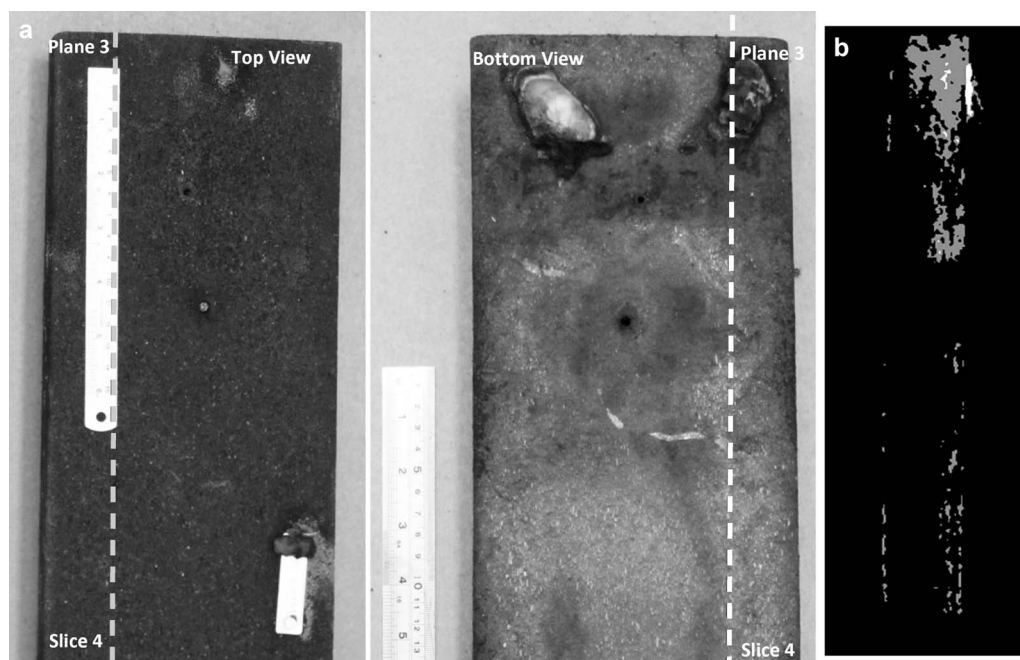
However, there is an apparent concentration of free water inside the sample near the top of the image (Fig. 17b). This moisture distribution pattern was similarly observed in a Plane 3 cross section from Side B of this sun board segment, obtained approximately 56 mm from the longitudinal edge of the board (Fig. 18). Again, there is clearly a moisture-rich layer at the exposed surface of the board; however, there appears to be a thin zone of high free water content in the core of the sample.

Figure 17.—Images of the sun board at Side A of the board showing (a) location of the slice and (b) magnetic resonance image obtained in Plane 3 of Slice 4.
