Properties of Aging Pentachlorophenol-Treated Douglas-Fir Crossarms

Christoph Schauwecker Milo Clauson Matthew J. Konkler
Arijit Sinha Jeffrey J. Morrell

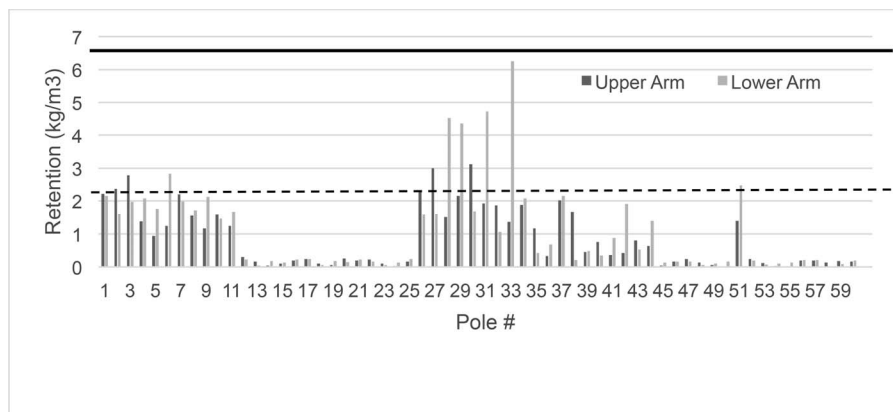
Penta retentions in the arms varied widely, ranging from 0 to 6.25 kg/m³ (Fig. 2). None of the retentions would meet the retention specification. There were also sometimes retention differences between the upper and lower arms in the same pole, but there were no consistent patterns, suggesting that the differences were a result of the inherent variation among different wood samples rather than an effect of position in the wishbone on subsequent preservative migration. It is difficult to infer much from the data because no initial retentions were obtained. However, the results, coupled with the absence of visible decay in the increment cores and the presence of decay fungi in only one of the 120 arms, suggest that the combination of a shallow pentachlorophenol treatment, coupled with the moderate durability of Douglas-fir heartwood, presented an excellent barrier against fungal attack. Previous studies have also noted the excellent performance provided by relatively shallow penta treatments in aboveground exposures (Scheffer and Eslyn 1978).

Figure 2.—Pentachlorophenol (penta) retentions in the outer 15-mm assay zone of 45- to 60-year-old Douglas-fir crossarms. The current American Wood Protection Association (AWPA) retention for penta for this application in Use Category 3B or 4A is 6.4 kg/m³ (AWPA 2019a), representing the upper horizontal line, while the dashed horizontal line represents an approximate threshold for protection against fungal attack in field stake tests.

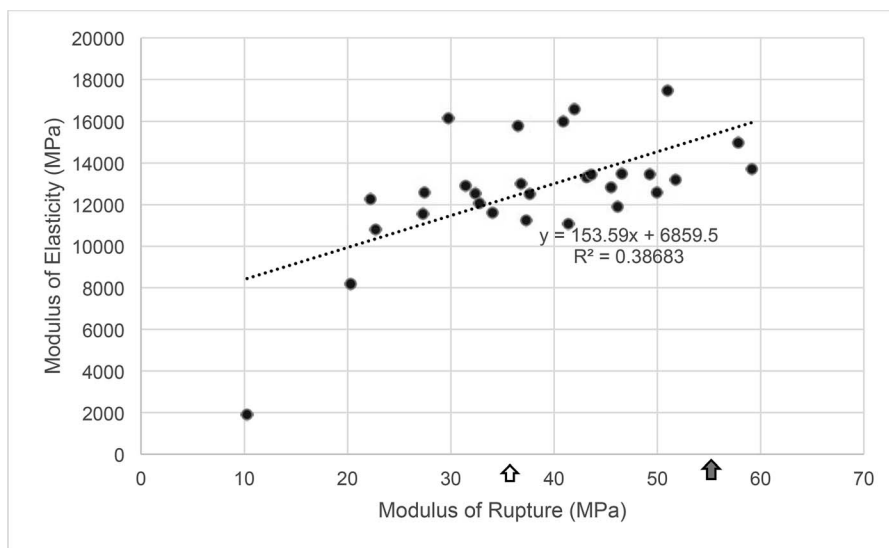
Figure 4.—Modulus of rupture (MOR) versus modulus of elasticity of Douglas-fir crossarms exposed in a wishbone configuration for 45 to 60 years and tested to failure in third point loading. Solid arrow on the x-axis corresponds to the assumed MOR of a new arm, while the open arrow corresponds to 67 percent of that value.

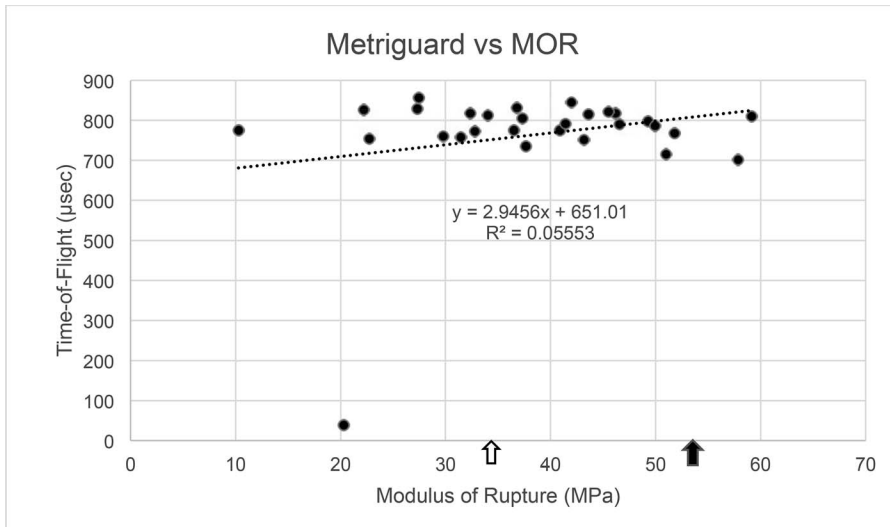
Figure 5.—Modulus of rupture (MOR) versus Metriguard time of flight assessment for 29 Douglas-fir crossarms exposed in a wishbone configuration for 45 to 60 years and tested to failure in third point loading. Solid arrow on the x-axis corresponds to the assumed MOR of a new arm, while the open arrow corresponds to 67 percent of that value.

The Metriguard system found little difference between arms that were above or below the minimum ANSI threshold. MOR was poorly correlated with the results from this device ($R^2 = 0.056$), and most time of flight measurements were between 702 and 857 μs (Fig. 5). The heavily checked surfaces as well as the presence of the holes drilled to accommodate attachments may have affected the functionality of this device. The MK-4 Hammer provides a value between 1 and 10 to denote decayed or sound wood, respectively. All of the results from the 29 arms were between 1 and 2.7, suggesting that the device was also

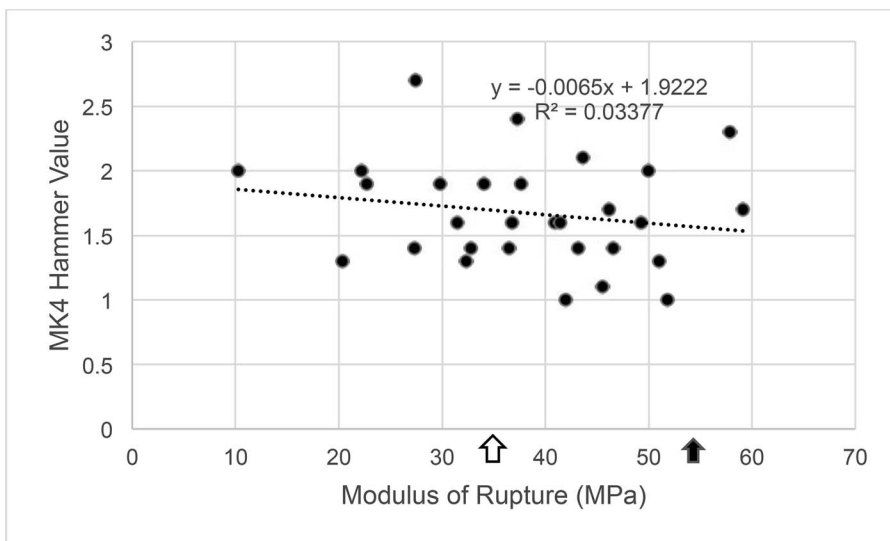
unable to accurately assess condition ($R^2 = 0.034$; Fig. 6). The MK-4 Hammer was able to detect the one heavily degraded arm, but it also tended to reject a number of other arms that full-scale destructive testing suggested still retained sufficient capacity. This conservative approach to sorting may be acceptable given the costs of an unplanned arm failure.

Figure 6.—Modulus of rupture (MOR) versus MK-4 Hammer assessment for 29 Douglas-fir crossarms exposed in a wishbone configuration for 45 to 60 years and tested to failure in third point loading. Solid arrow on the x-axis corresponds to the assumed MOR of a new arm, while the open arrow corresponds to 67 percent of that value.
