Field Performance of Glued Laminated Timber (Glulam) Manufactured from Thin Treated Lamina

Rod Stirling
Robert M. Knudson
Martin W. Feng
Paul I. Morris

Forest Prod. J. 72(1):29–36.

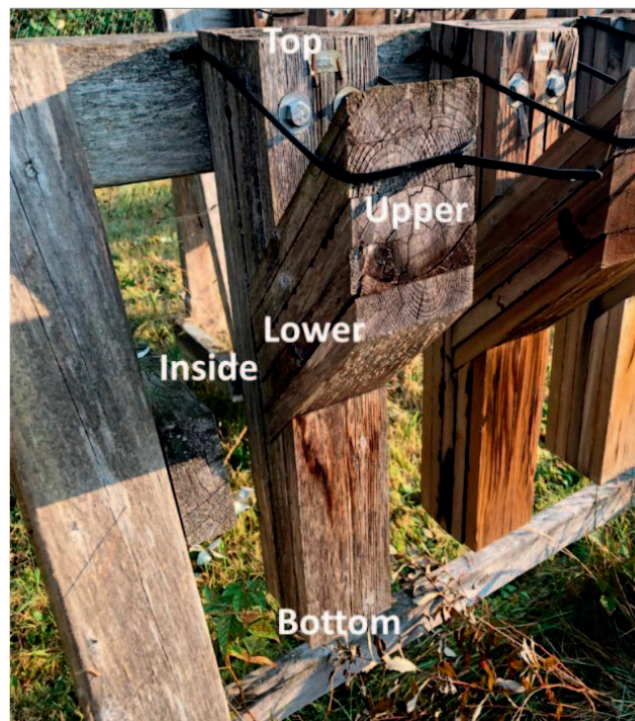
Figure 1.—Above ground (gamma joint) decay test of treated glulam after 12 years of exposure in Maple Ridge, British Columbia.

Gamma joints.—After 12 years of exposure, untreated gamma joints had failed or were severely decayed (Table 3). The treated gamma joints showed signs of early decay with average decay ratings ranging from 9.2 to 9.8. Decay was

most often found on the top of the vertical member, the inside face, and on the lower angle.

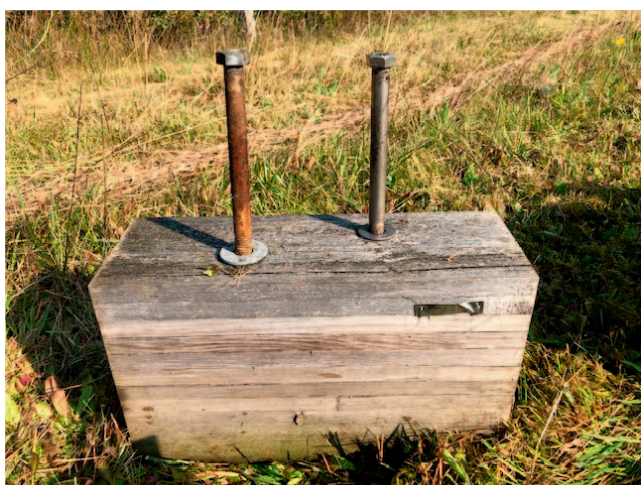
Figure 2.—Ground proximity test unit showing galvanized (left) and stainless-steel (right) bolts after 10 years of exposure in Maple Ridge, British Columbia.

minimum rating of 7.6. Glulam made from lodgepole pine or Pacific silver fir lamina treated with ACQ exhibited early stages of decay. The greatest extent of decay was observed on the sample ends and on the bottom surface that was in contact with the concrete block. At 5 years it was hypothesized that lower extent of decay on the galvanized bolt side of the untreated controls may have been due to the protective effective against decay of the zinc leaching from the galvanic coating. At 10 years the average decay ratings on each end were very similar, suggesting that any protective effect from the zinc was short-lived, and that this would not make up for the absence of a primary treatment. Such an effect may also be less important in wood treated with a preservative that contains mobile copper because this would also provide protection to the bolt hole (Morris et al. 2004).

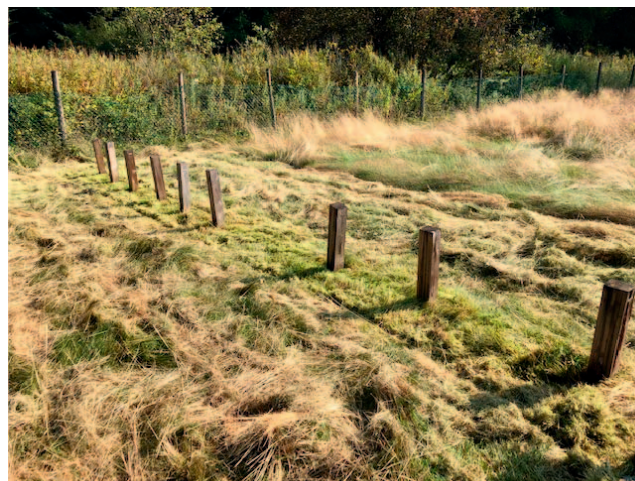
Figure 3.—Treated 5-ply glulam samples from one quadrant in the ground contact test after 10 years of exposure in Maple Ridge, British Columbia.

Ground contact.—After 10 years of exposure, advanced decay was observed in the untreated controls (Table 4). Pacific silver fir had the most advanced decay, likely due to the low natural durability of its heartwood (Morris et al. 2014). Early stages of decay were observed in all treated groups with average decay ratings ranging from 8.7 to 9.3. It is clear from looking at the average decay ratings, that the untreated controls are highly vulnerable to decay and that both ACQ and CA treatments greatly slow this process (Fig. 5). More time is needed to define the service life, with respect to decay, of the treated glulam in this exposure.

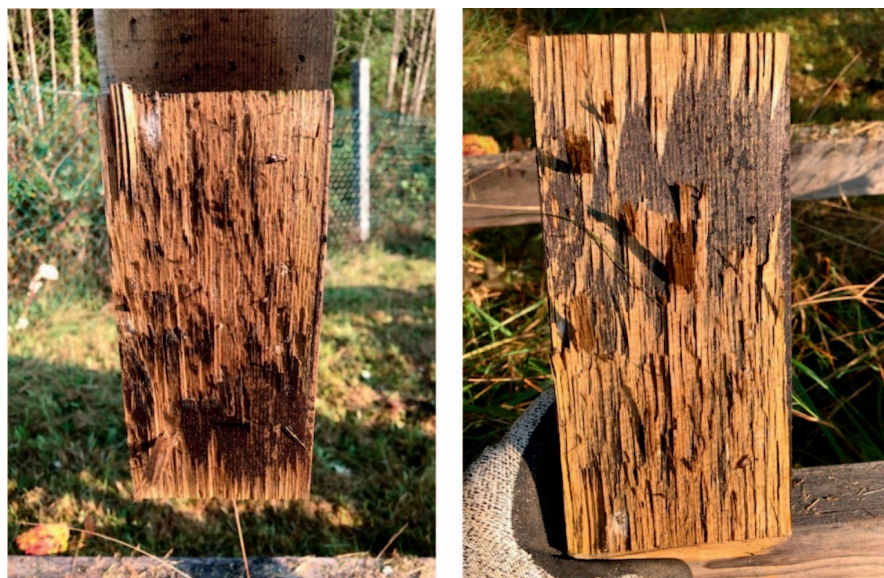
Twelve specimens failed as a result of delamination during inspection or in previous years. All species and all treatments had at least one delamination failure. Failures occurred in a similar manner in all specimens, always occurring near the lamination closest to the bottom of the interior joint of the vertical member. This would have been the most stressed bond line because of the weight of the angle piece and the water trapping. Observation of the delamination showed a high percentage of wood failure near

the bond line (Fig. 4), suggesting that the wood near the bond line may have been weakened by the pressing of the lamina prior to gluing. There were also signs to indicate that the roll-pressing of the lamina prior to gluing did not achieve sufficiently flat surfaces to allow complete intimate contact between lamina along the bond line. These data suggest that this method may not be an appropriate way to manufacture treated glulam, or that tighter controls on the temperature and moisture content of the wood and the force applied to the wood would need to be defined to minimize or eliminate crushing of the cell walls but also ensure adequate

Figure 4.—An example of delamination failure in one of the gamma joint test units. The lighter colored sections indicate wood failure.

smoothness on lamina surfaces, and these would need to be implemented into the process. This contrasts with other work that has shown that lamina treated with copper-based preservatives can be effectively bonded with replaning or resurfacing following treatment (Lee et al. 2006, Podgorski and Legrand 2006, Gaspar et al. 2010, Yang et al. 2012, Dias et al. 2020).

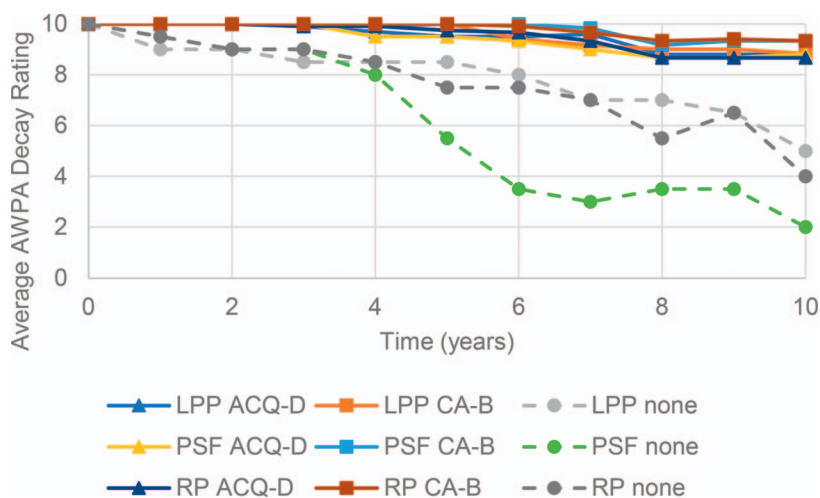
Figure 5.—Average decay ratings of lodgepole pine (LPP), Pacific silver fir (PSF), and red pine (RP) treated and untreated glulam over 10 years of exposure in a ground contact test in Maple Ridge, British Columbia.

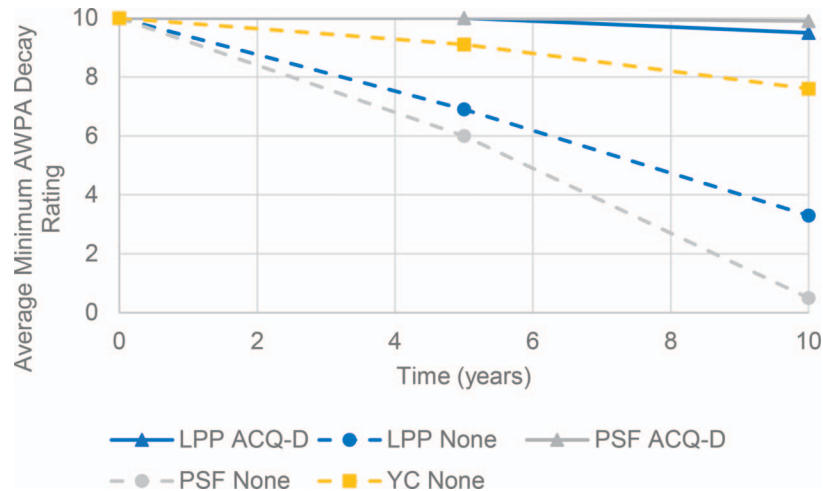
Ground proximity.—After 10 years of exposure, the majority of untreated lodgepole pine and Pacific silver fir 12-ply glulam specimens had failed as a result of decay or exhibited advanced decay (Table 5, Fig. 6). The yellow cedar reference exhibited moderate decay with an average

Figure 6.—Average decay ratings of untreated yellow cedar (YC) and treated and untreated lodgepole pine (LPP) and Pacific silver fir (PSF) glulam over 10 years of exposure in a ground proximity test Maple Ridge, British Columbia.
