# Aboveground Decay Resistance of Selected Canadian Softwoods at Four Test Sites after 10 Years of Exposure

Paul Ian Morris      Peter Laks      Glenn Larkin  
Janet K. Ingram      Rod Stirling

©Forest Products Society 2016.  
Forest Prod. J. 66(5/6):268–273.  
doi:10.13073/FPJ-D-15-00052

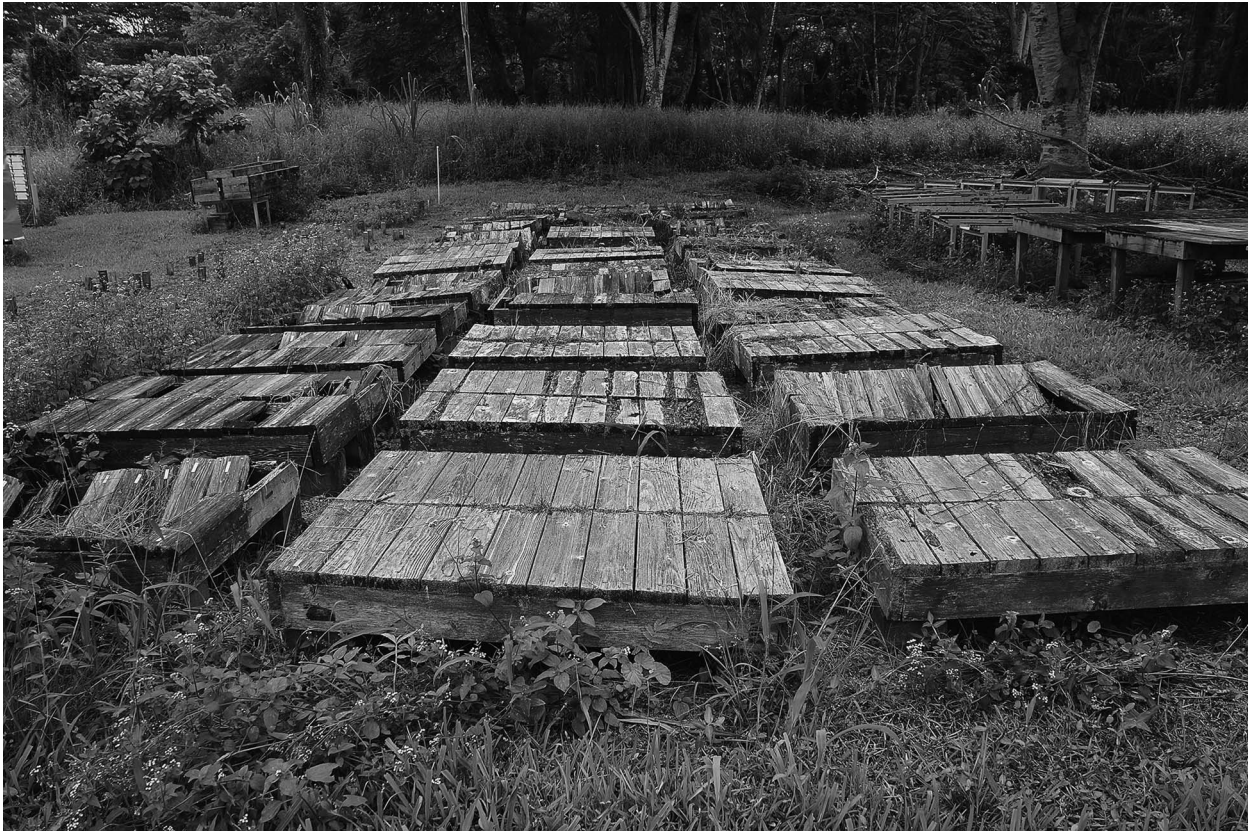
Figure 1.—Decking test units at the Kipuka test site in Hawaii after 7 years of exposure.

The exposure assemblies were constructed and installed using methods later standardized as AWP standard E25-08 (American Wood Protection Association [AWPA] 2008). Two decks were prepared for each wood species and type for installation at each site. Each of 20 2 by 6-inch test boards was cut into four 500-mm boards, one for each site. In addition, a 50-mm reference sample was taken from each board for future analytical work if warranted. The decks were constructed using stainless steel screws, with the 20 experimental boards mounted in two rows of 10 boards. One row of deck boards was coated on all sides with a commercial deck water-repellent stain (Natural Deck Oil, Napier Inc.), while the other row was left unstained. The decks at the Maple Ridge, British Columbia, test site were refinished with the same stain after 3 years in service. All other decks were left without refinishing. The decks were mounted on leveled concrete blocks with the base of the frames 50 to 100 mm above the ground at four test sites (Table 1; Fig. 1). More detailed descriptions of the test sites are provided by Morris et al. (2011).
