# Effect of a Water Repellent on Moisture Intrusion Patterns in Small-Scale Mass Ply Panel Floors

Forest Prod. J. 75(4):426–432.

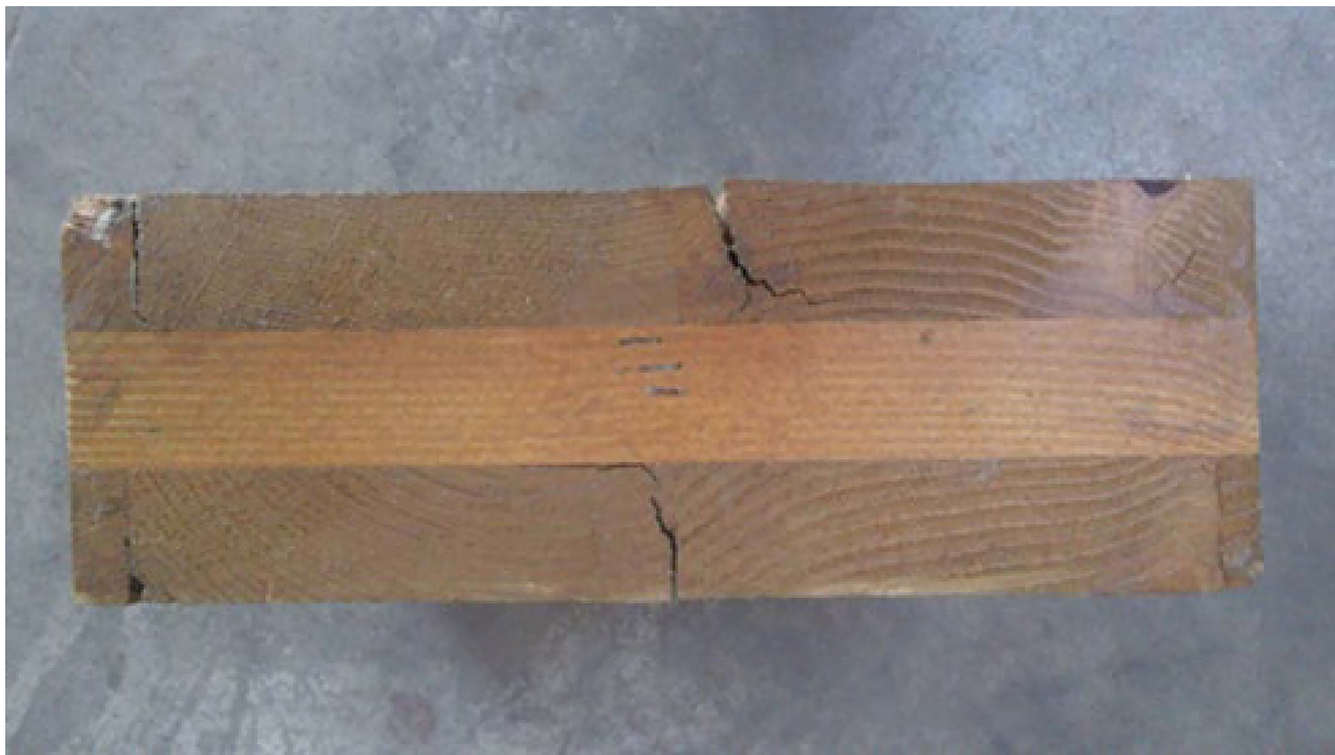
Figure 2.—Example of a Douglas fir cross-laminated timber panel section exposed to natural rainfall for 30 days and air dried for 2 years showing checking and delamination.

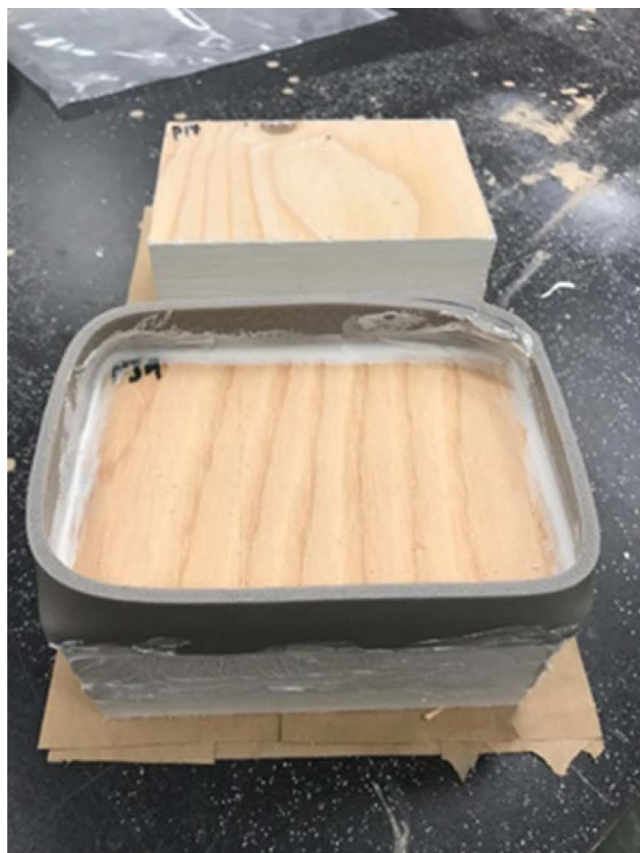
Figure 3.—Examples of a mass ply panel block: before sealing (top); sealed with the water well (bottom).

The MPP was cut into 100-mm by 153-mm-long sections that were conditioned to stable mass at 20°C and 65 percent relative humidity. The exposed veneer edges were sealed with an elastomeric coating to retard moisture loss. A 25-mm-wide closed-cell gasket was attached around the sides with caulking to create a well at the top. The gasket was also secured with staples to minimize leakage. Later versions eliminated the elastomeric because there was little evidence of leakage from the sides of the blocks (Fig. 3). Nine assemblies were left as noncoated controls, whereas the upper surfaces of an additional nine samples received two coats of a high solids water repellent applied with an absorbent paper towel with 10 minutes between coats. The water-based coating (LotusPro, Arxada, Alpharetta, Georgia, USA) contained 46 g/L of volatile organic compounds. The assemblies were weighed before and after each coat to determine net water-repellent application. Each block received an average of 1.82 mg/cm<sup>2</sup> of solution.

The samples were weighed, water was added to a depth of approximately 10 mm in the well, and the assembly was placed into a plastic bag to retard drying. The samples were incubated for 1, 4, or 7 days. Additional assemblies without water repellent were exposed for 18 and 24 days to assess the effect of prolonged wetting. Water was added as needed. Each time point was replicated on a minimum of three assemblies. The assemblies were removed at the appropriate time point, the water was poured out of the well, and the wetted surface was blotted with a paper towel to remove excess moisture.

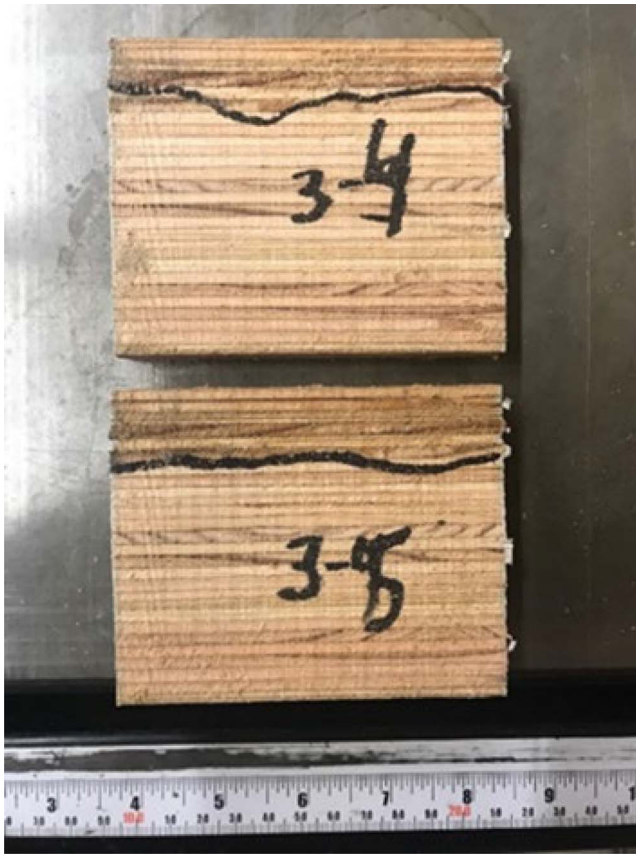
Figure 6.—Cross cuts of an mass ply panel without a water repellent showing moisture intrusion (darkened area above the marker) after 7 days of wetting.

veneers beneath the surface in each panel (Fig. 6). Leakage issues led to some wetting of the underside of the test pieces, which skewed the data, but the overall trend was sharply decreased moisture levels with distance from the upper wetted surface (Fig. 6).
