Exterior Decay of Wood–Plastic Composite Boards: Characterization and Magnetic Resonance Imaging

Forest Prod. J. 66(1/2):4–17.

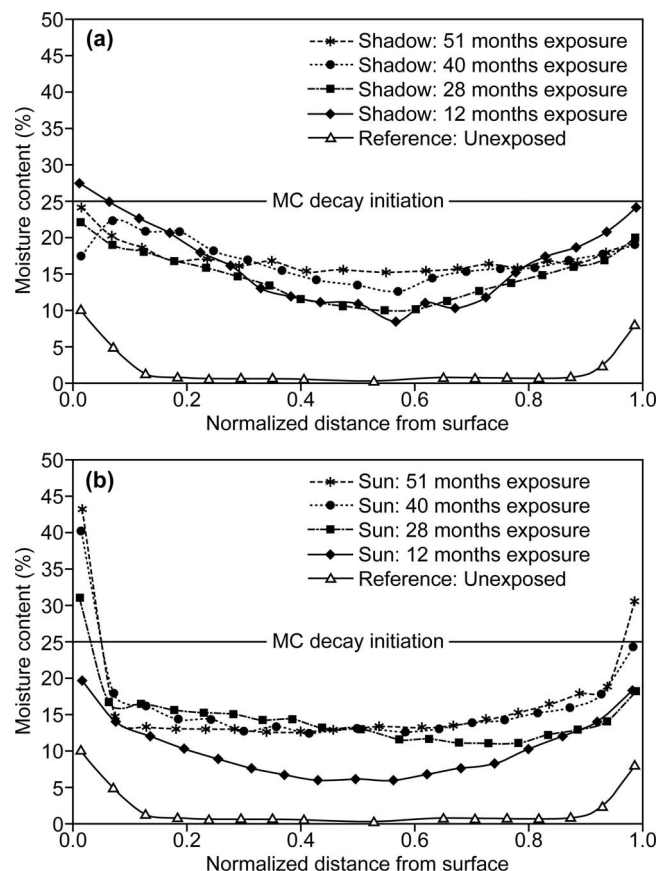
Figure 6.—Moisture content and distribution of (a) shadow and (b) sun boards during their first 51 months of exposure near Hilo, Hawaii.

MC and distribution of the WPC boards during the first 51 months of exposure in both shadow and sun locations are shown in Figure 6. MC and distribution in the graphs indicate relatively moderate WA by the boards during this period. The increase of MC in the core of the boards to 15 to 20 percent after 51 months of exposure seemed to approach the equilibrium MC associated with wetting and drying cycles. The MC in wood exceeded 25 percent only in narrow zones near the board surface in both sun and shadow locations. No severe degradation of the WPC board by
