Supplemental Treatments for Timber Bridge Components

H. M. Barnes
T. L. Amburgey
M. G. Sanders
G. B. Lindsey

Abstract

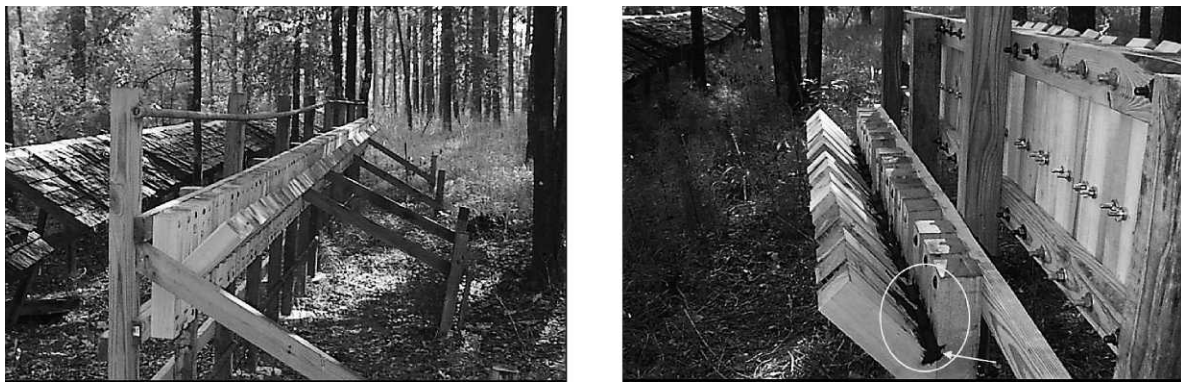
Figure 2.—Post-rail units exposed on vertical test fences at the Dorman Lake test site in American Wood-Preservers' Association Hazard Zone 4 (units on right have preservative paste applied to the joint [circle]).

Supplemental treatments.—P-R units were constructed (1) with and without porous pads (felt) placed between the joining timbers (Fig. 1; Amburgey et al. 2007, 2009; Amburgey and Sanders 2008; Sanders and Amburgey 2009); (2) with holes bored adjacent to joints to serve as fumigant or preservative reservoirs; or (3) wood-to-wood joints alone. These configurations tested the efficacy of pads or capped holes as reservoirs for supplemental treatment chemicals. Treatments consisted of injecting or applying a fumigant (WoodFume, Osmose Co.), solvent-borne preservative (copper naphthenate), water-repellent preservative (copper naphthenate plus paraffin), diffusible borate rods (Impel rods, Viance Corp.), waterborne borate preservative (BoraCare, Nisus Corp.), and copper-borate paste (CuRap 20, ISK Biocides). The focus was on the use of candidate systems with lower environmental impact. Test units were placed on specially designed test fences at the Dorman Lake test site (Fig. 2).

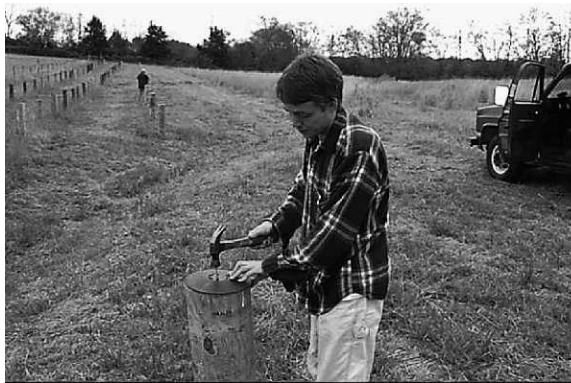
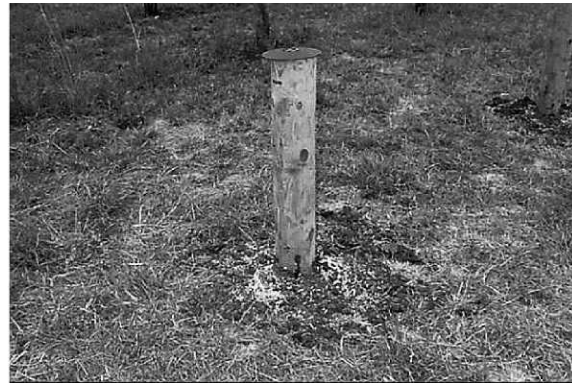
Figure 3.—Installation of caps and pole stubs in the test plot.

plugged with Caplug L-11 plugs. Pole stubs had a ProTop (Bayne Co., Spokane, WA) cap placed on the top to protect the end grain from rain wetting (Fig. 3).

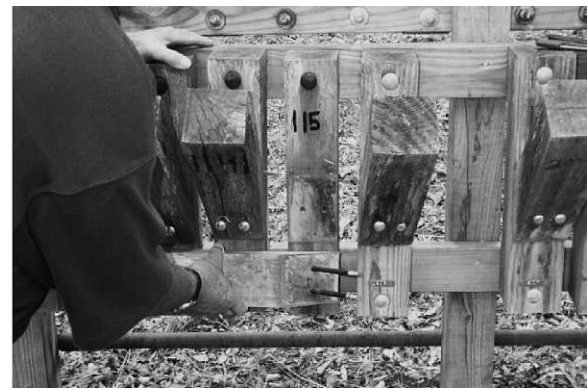
Figure 5.—Post-rail units exhibiting poor (left) and excellent (right) performance after 44 months of exposure.

The group average condition for the P-R units after the 12-, 25-, and 44-month inspections is given in Table 3. Typical performance is shown in Figures 4 and 5. Ratings for treatments applied to holes are compared with untreated P-R units in Figure 6. For yellow-poplar, no treatment applied in holes was considered effective, with an average rating across all treatments of 2.85 after 44 months of exposure. Across all species, the waterborne borate (average = 1.27) and boron rod (1.33) treatments were shown to be most effective. The waterborne borate was the most effective treatment applied to holes for red oak. It was also the most effective treatment for southern pine. Fumigant treatment was not long-lived on any species, as is clear from the 44-month ratings. This likely was due to the short lengths of the P-R members, which permitted loss of fumigant. Work with refractory pole species indicates a longer-lived effectiveness for fumigants (Morrell et al. 2004).

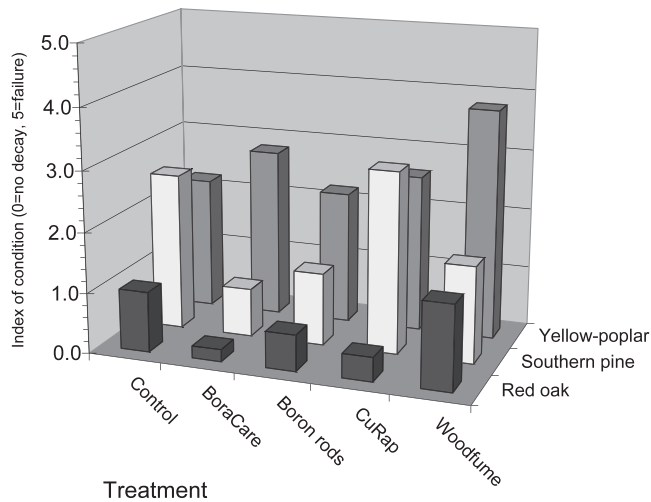
Figure 6.—Comparison of effectiveness of treatments applied to holes adjacent to joints in post-rail test units after 44 months of exposure.

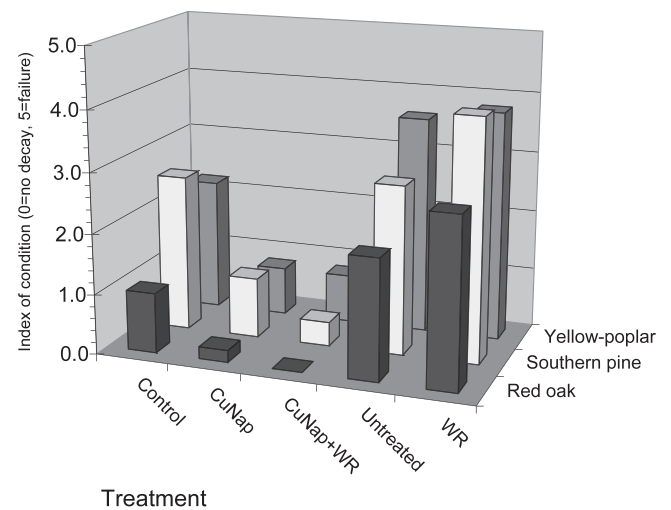
Figure 7.—Comparison of performance ratings for treatments applied to felt pads at joints in post-rail (P-R) test units after 44 months of exposure. Controls are untreated P-R units with no felt pad at the joint. Untreated refers to nontreated felt pads at joints in P-R units. CuNap = copper naphthenate; WR = water repellent.

A comparison of systems applied to felt pads (Fig. 7) included a water repellent and a 1 percent copper naphthenate solution with and without water repellent. The copper naphthenate treatments with or without water

repellent were by far the most effective treatments for all species. The addition of a water repellent alone generally decreased performance compared with controls since they provided no biocide to prevent decay and no water repellency to the wood.

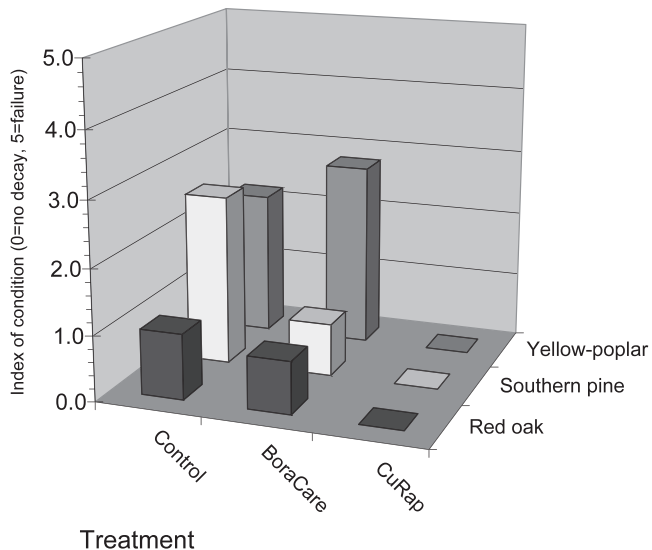
Figure 8.—Comparison of treatments applied directly to the wood-wood joints in post-rail test units after 44 months of exposure.

In joints constructed without felt pads, the copper-borate paste troweled into the joints was completely effective for all wood species (Fig. 8). Recall that copper-borate paste performance when applied to holes was rather poor. This seems to indicate that there was not enough moisture to move the copper-borate paste into the joints from the adjoining holes; whereas, movement did occur when the copper-borate paste was applied directly to the joint. In practice, the copper-borate paste could be applied to joints using a modified grease gun. Results indicate that this procedure would significantly decrease decay at joints if it was a part of a regular maintenance program. The waterborne borate system was effective in southern pine and red oak but ineffective with yellow-poplar.

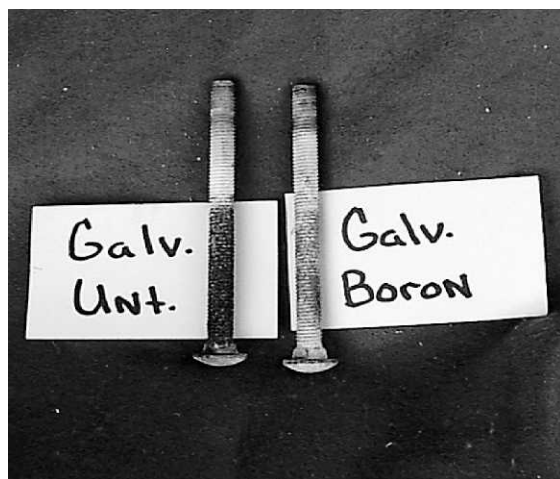
Figure 9.—Corrosion of galvanized bolts was much less in those that had been dipped in BoraCare (1:1) prior to use (left) and a corroded galvanized fastener in an oak test unit (right) after 44 months of exposure.

Iron deterioration at fastener points did not occur in units whose bolt shanks were fitted with heat-shrink tubing, but the unprotected bolt heads and nuts corroded in those exposed in oak test units. The shanks of bolts not protected with heat-shrink tubing had corrosion, especially those in oak test units. Corrosion was significantly less in bolts without heat-shrink tubing that had been dipped in BoraCare prior to use and/or the bolt holes had been treated with BoraCare (Fig. 9). These procedures should be considered when specifying fasteners for bridges and other exposed framing, especially when the structures involved are near salt water.

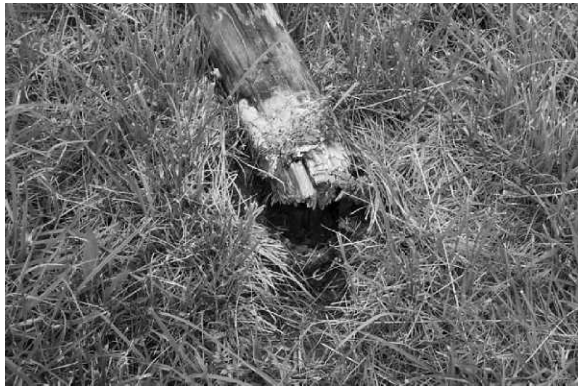
Figure 10.—Typical failed untreated pole stub after 41 months in service in American Wood-Preservers' Association Hazard Zone 4.

specimens. Each pile was rated individually and group averages were calculated for each treatment group for the three exposure periods (Table 4). Figure 10 shows a typical failed pole. Pole stubs treated with in-place treatments containing pastes or grease, alone or in combination with other treatments, remained sound after 41 months of exposure. These results can be seen in Figure 11 and illustrate the effectiveness of pentachlorophenol grease and boron- or fluoride-containing paste systems. Figure 12 shows typical performance of boron and fluoride rods after 22 months in service. Except for the fumigant-boron rod treatment combination, these treatments performed no better than the untreated controls (Table 4). As with the P-R study, the short length of the pole stubs likely was responsible for the loss of fumigant used to treat them.

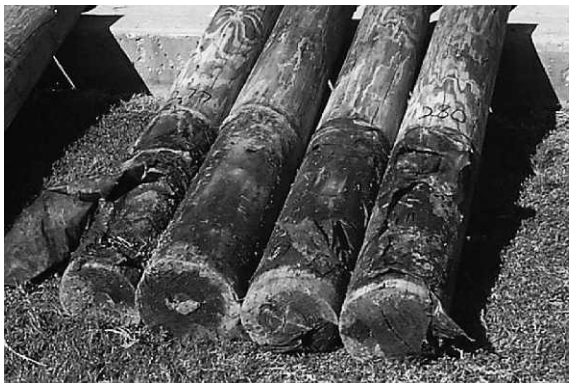
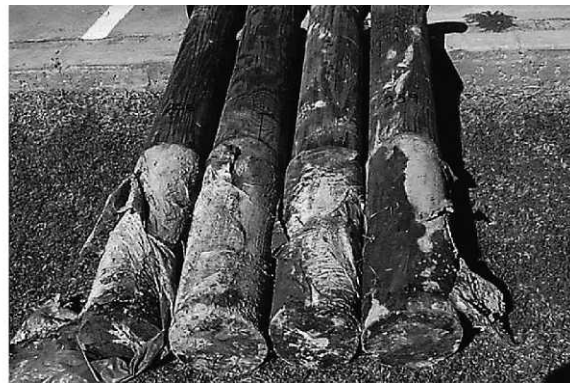
Figure 11.—Typical performance of fluoride paste (left) and copper borate paste (right) treatments with no decay after 41 months of exposure in American Wood-Preservers' Association Hazard Zone 4.

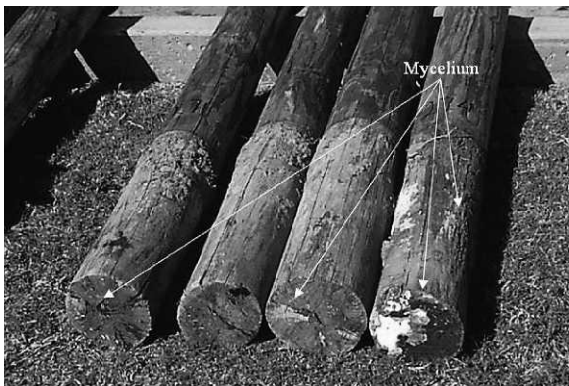
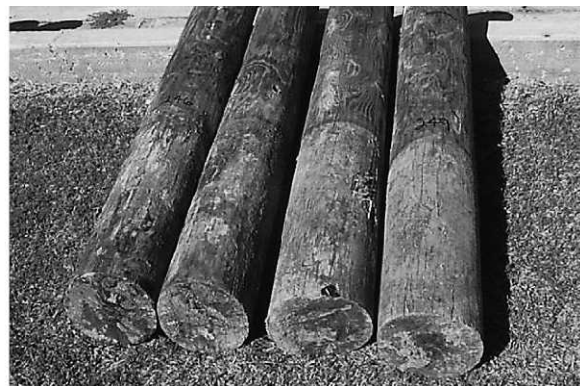
Figure 12.—Performance of fluoride (left) and boron (right) rod treatments after 41 months of exposure in American Wood-Preservers' Association Hazard Zone 4.
