Repair of Partially Embedded Metal Connector Plates

Forest Prod. J. 66(3/4):225–232.

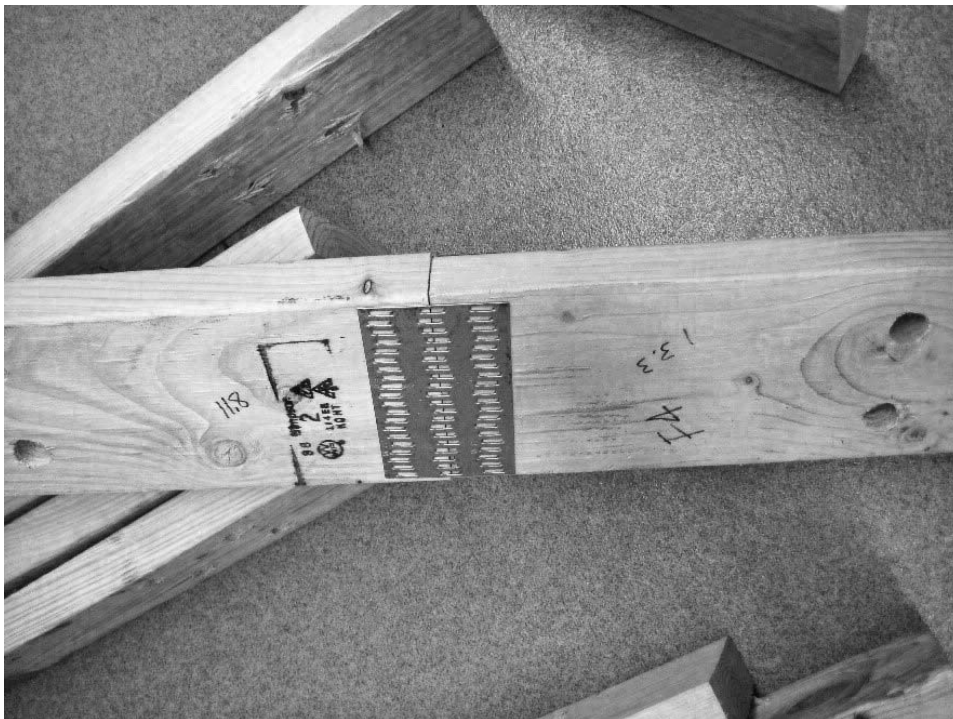
Figure 1.—F4 test specimen after fabrication.

Two wood pieces were attached with 5 by 3-inch Alpine 20-gauge Wave Plates with an AA orientation, as shown in Figure 1. All of the connector plates were pressed in a controlled laboratory setting using a hydraulic platen press. The fully embedded specimens were pressed to close to a 0-inch gap between the metal plate and the wood without overpressing. Fully embedded specimens were not pressed farther than half of the metal plate thickness into the wooden test specimens. All of the partially embedded specimens were pressed with 1/16-inch steel shims placed between the wood members and metal connector plates. The plates were pressed until contact with the steel shims was achieved.

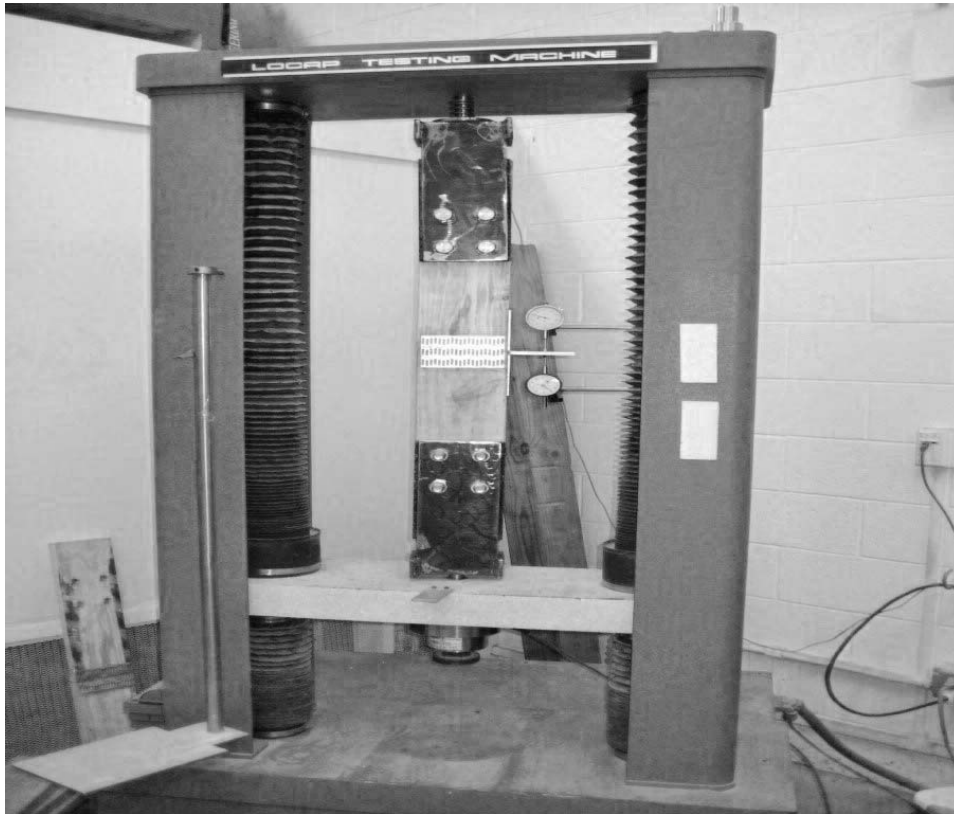
Figure 4.—Test specimen mounted in the testing machine.

Testing was performed in accordance with ANSI/TPI 1-2007 standards and occurred 14 days after specimen fabrication. Immediately prior to testing, the connector plate locations on the front and back sides of the specimen were measured with respect to the ends and sides of the adjoining wood members. Moisture content was also measured for each specimen and ranged from 12 to 17 percent, consistent with moisture contents at time of fabrication (10% to 18%). Embedment depth was measured at eight locations. The specimens were loaded in tension as shown in Figure 4, at a constant load rate of 25 lb/s until failure, defined as a loss of 90 percent of the peak load. During testing, the amount of slip at the splice connection was measured using dial gauges with 0.001-inch precision every 15 seconds. These data were plotted to produce load-versus-slip curves for each specimen.

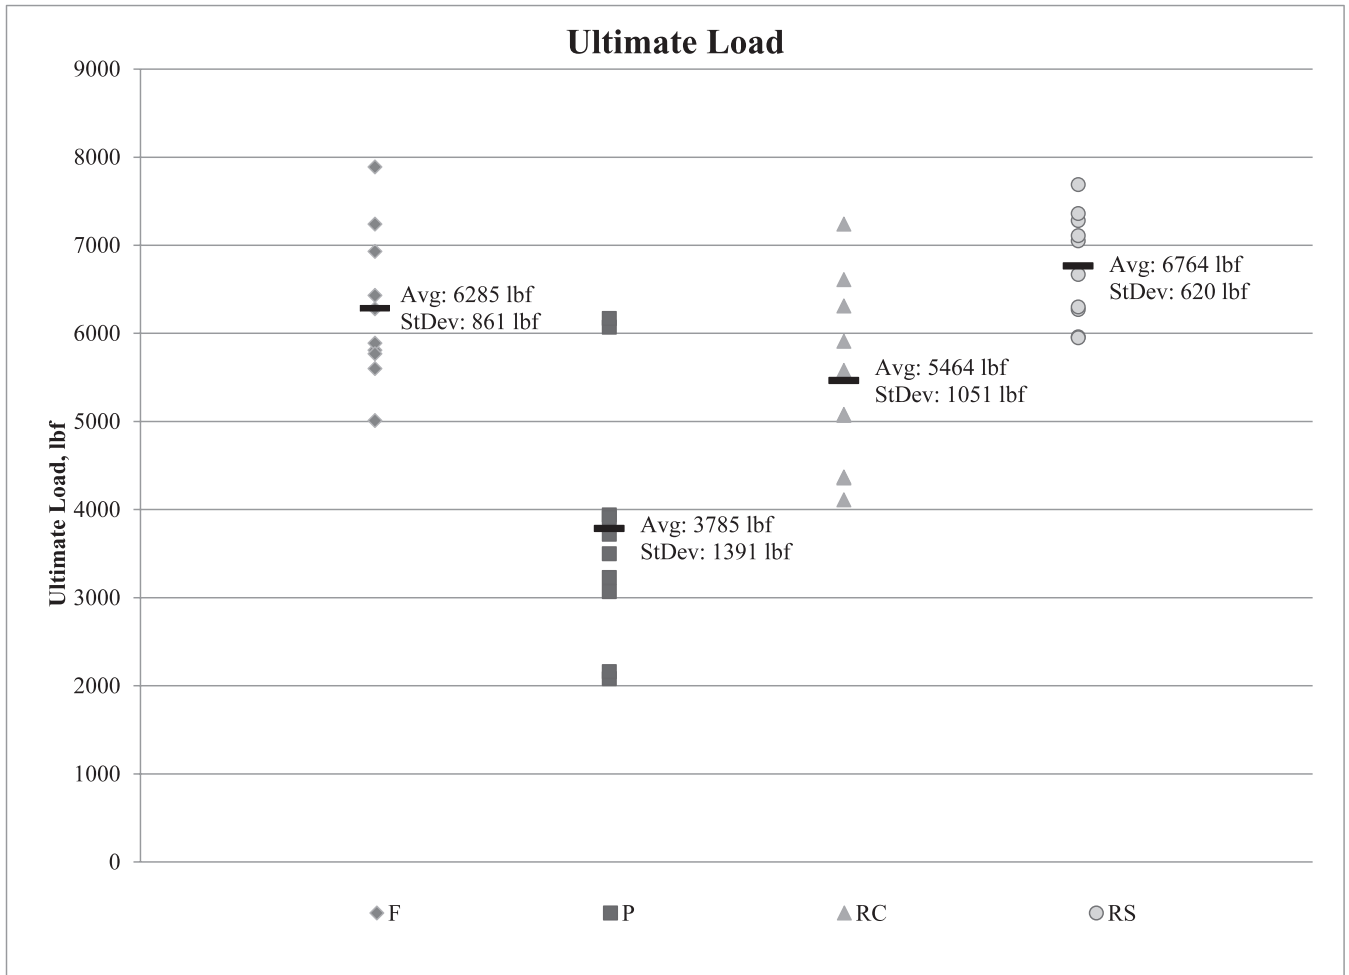
Figure 5.—Comparisons of ultimate load for each specimen group.

embedded, RC, and RS specimens. Figure 5 details the ultimate tensile loads of all 40 specimens graphically and includes the average and standard deviation of the ultimate loads within each group.

Both RC and RS repairs clearly showed a significant return of strength to the connections with partially embedded plates. The RC repair yielded ultimate loads an average of 87 percent of the strength of the fully embedded specimens. The RS repair showed an increase in ultimate load capacity beyond that of the fully embedded specimens to 108 percent. In addition to the average ultimate load being greater with the RS repair, the standard deviation of the results was also smaller. This shows that the repair was more consistent in restoring the strength of the partially embedded connections within group RS. Statistical analysis using a Student's *t* distribution gives a 92 percent confidence that the mean strength of the RS specimens is greater than the fully embedded specimens and a 96 percent confidence that the mean of the fully embedded specimens is greater than the RC specimens.

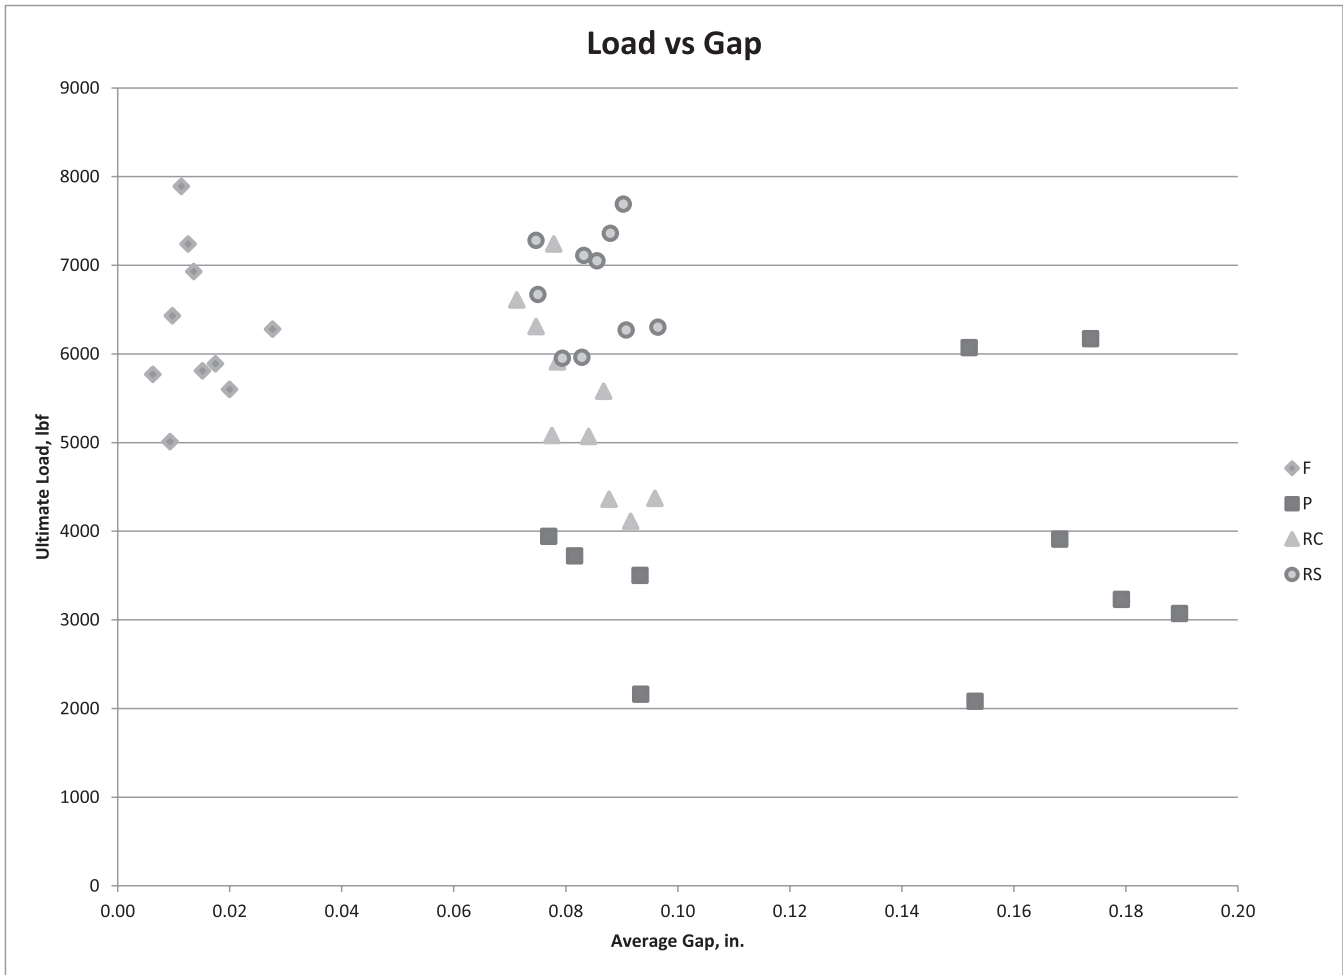
Figure 6.—Comparisons of ultimate load to average embedment gap.

Figure 6 shows the ultimate load-versus-gap data. Owing to some rebounding of the plates after pressing, the measured gap between the connector plate and wood member was typically 0.071 to 0.096 inch for the partially embedded plates, which is greater than the 1/16-inch shims used to cause partial embedment. However, six of the partially embedded nonrepaired specimens had partial embedment gaps of 0.152 to 0.190 inch. While the gaps were larger than anticipated, the ultimate loads of those specimens were, in fact, consistent with the other partially embedded control specimens.
