Estimating the Impacts of Preservative Ports on Bridge Tie Strength

Adam Taylor Richard Bennett David Paul Harper Jeff Lloyd

Abstract

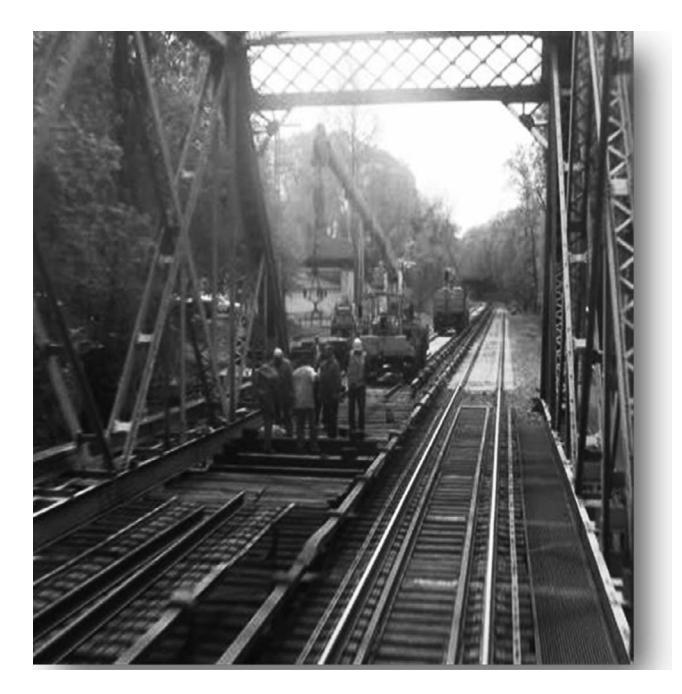
Figure 1.—Typical open-deck railroad bridge.

Many railway bridges in the United States have "open decks" (no ballast) with large bridge timbers that rest on the main bridge structure (Fig. 1). Unlike railroad ties that are supported by a ballast, the bridge timbers are structural members that carry load from the train cars to the main structural system. Replacement of bridge timbers is typically a slow, labor-intensive process that presents its own set of worker safety risks and creates a bottleneck in track maintenance.

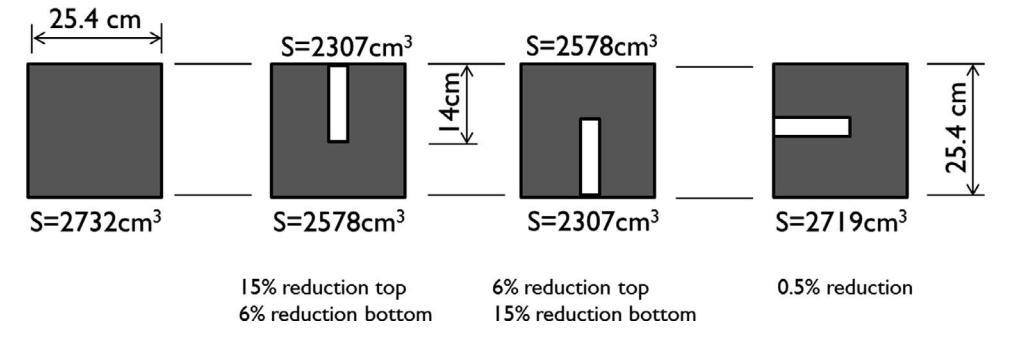
Figure 2.—Reduction in section modulus for various locations of holes.

When designing wooden railway bridges, both bending and shear in the bridge timbers need to be considered. The bending strength of the timber is related to the wood properties and to the section modulus, a geometric property used in the flexural design (AREMA 2015). Holes in the side cause virtually no reduction in the section modulus (Fig. 2), and the bending stress is zero at the mid-height or neutral axis (for a symmetrical section) and greatest at the top and bottom. Typically, holes have less effect on the compressive strength of the beam, so-for bending-it would generally be better to drill the hole in the top of the beam (the compression face, instead of the bottom of the beam (the tension face).

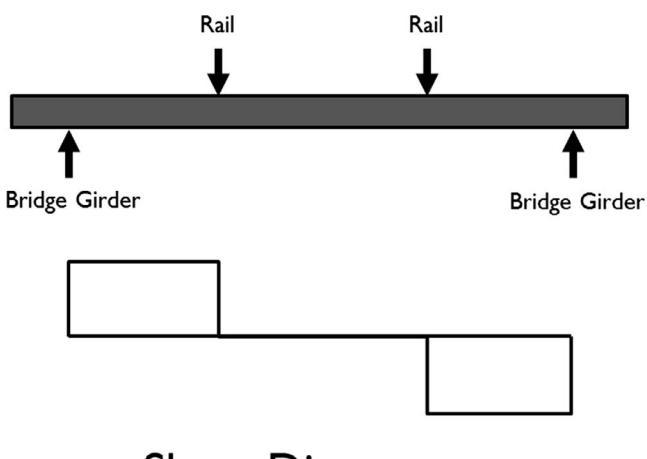
Shear Diagram

Figure 3.—Shear diagram of bridge timber.

Shear is constant between the support and the rail, and zero between the rails (Fig. 3; Hibbeler and Kiang 2015). Shear stress is highest at the mid-height of the beam, and varies quadratically, with a zero shear stress at the top and bottom of the beam. Theoretically, a hole in the top or bottom of the timber would reduce the shear strength by 20 percent, and a hole in the side of the beam would reduce the shear strength by 55 percent. However, this analysis implicitly assumes a continuous hole along the length of the beam, or a slot; the behavior with just the hole is quite complicated. Thus, a testing program was used to estimate the impact of holes on the strength of small models of bridge timbers.

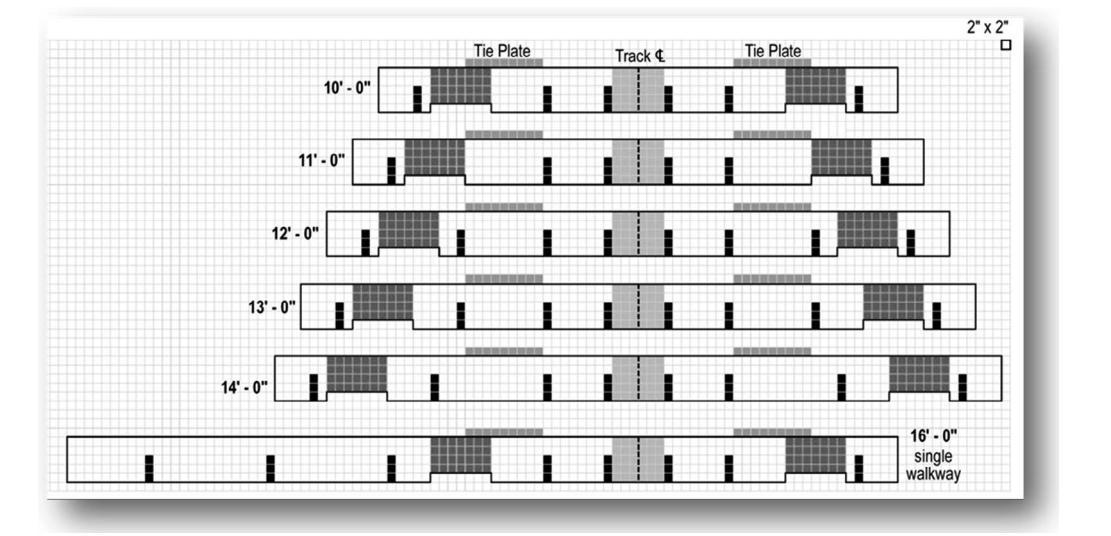
Figure 4.—Bridge timbers of various lengths, showing potential preservative port (hole) locations in black.

Typical bridge timbers are large; however, full-scale testing is not necessary and may confound the effect of geometry with natural defects from the wood. Therefore 2 mm:2.54 cm (0.079 in.:1 in.) scale models were used. Small, clear, mostly straight-grained samples of southern yellow pine (*Pinus* spp.) and red oak (*Quercus* spp.) were sawn from kiln-dried lumber. Samples were 20 by 20 by 340 mm (0.87 by 0.87 by 13.39 in.) long to represent a $10-in^2$, 14-ft-long bridge timber (note: the industry uses English units). A 14-ft (4.3-m)-long timber was chosen as the worst-case scenario among the options represented in Figure 4—it has the longest span between the supports, which results in the highest bending moment.

Holes (4 mm [0.16 in.] in diameter) were drilled in the beams to a depth of 12 mm (0.47 in.), as indicated by the black bars in Figure 5. Holes were drilled either on the top, side, or bottom of the beams. Control beams had no holes. "Daps," which are cutouts on the bottom that accommodate the beams' supports in industrial practice, were cut using a dado blade on a table saw. Daps were to scale: 4 mm deep

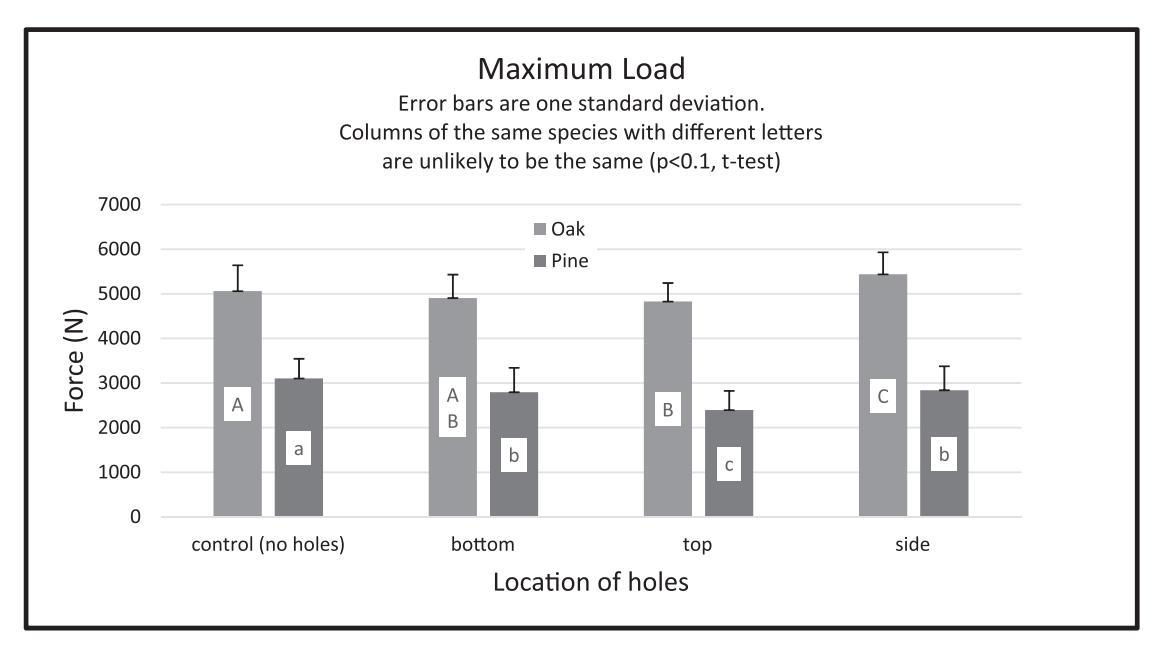
Figure 5.—Average load to failure of scaled bridge timbers (n = 30).

The oak beams were stronger than the pine, as expected for a denser wood species (Fig. 5; Forest Products Laboratory [FPL] 2010). The holes only slightly reduced the average maximum load supported by the beams, with the holes drilled on the top of the beam being the most damaging. The impact of the holes was similar for both species.

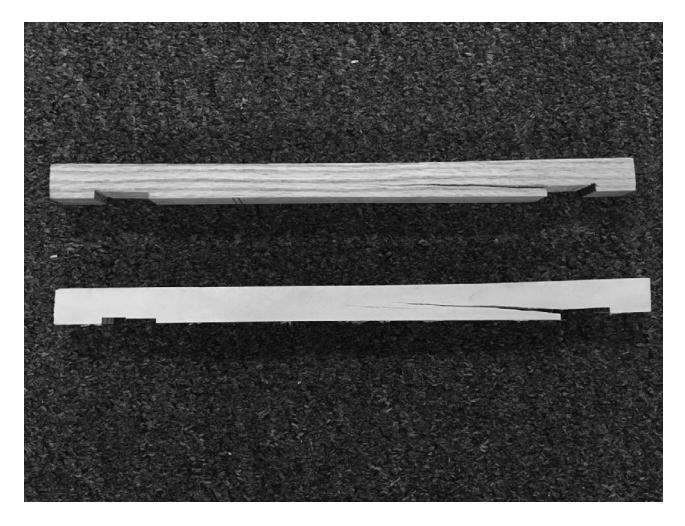
Figure 6.—Typical failure pattern in the scaled bridge beams. Red oak on top, pine below.

The beams tended to show shear-type failure originating at the daps (Fig. 6). The beams almost never failed in the extreme fibers at the center of the span, as might have been expected in a bending test. This suggests that the dap contributed to the failure mechanism. This may also explain why the holes in the top had more effect than that predicted; the dap effectively reduced the height of the beam near the ends and the top holes were reducing more of the effective cross section than the bottom holes.

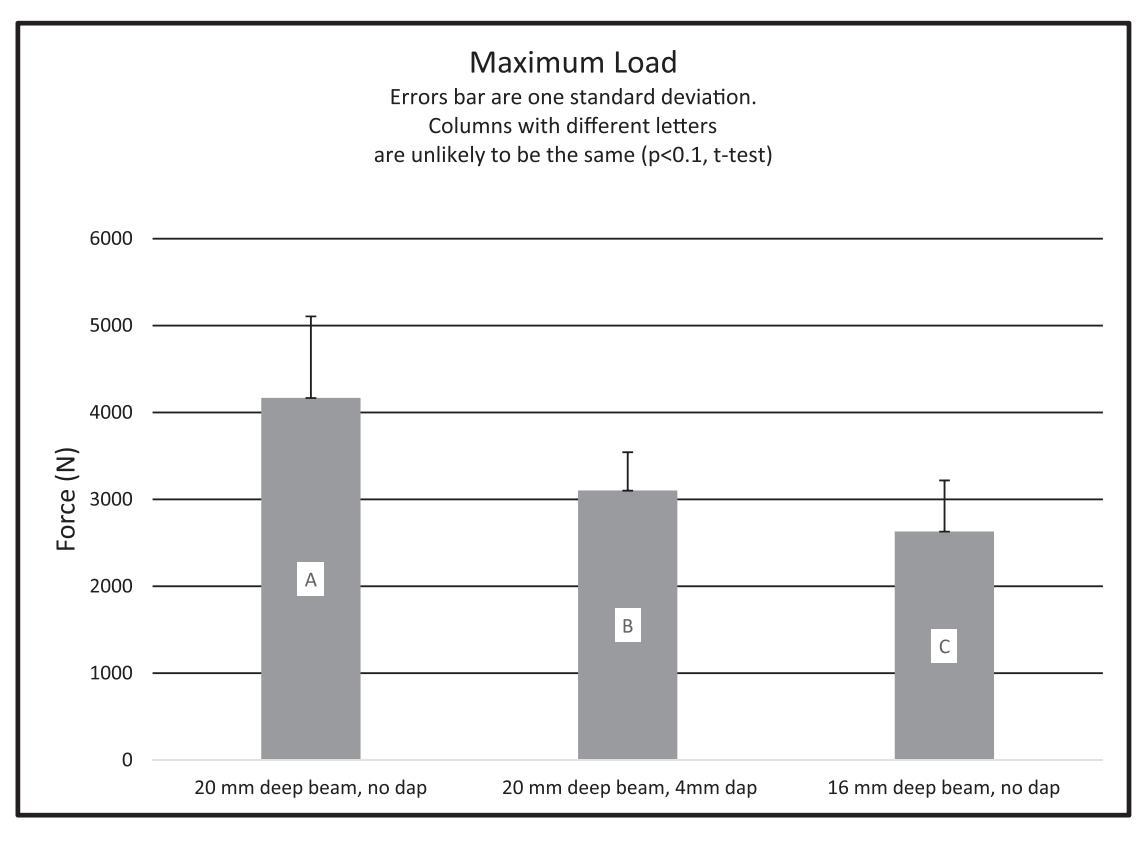
Figure 7.—Effect of dap on pine scaled bridge timbers (n = 30).

and with and without daps. An additional group of beams was sawn down to a uniform thickness along its length of 16 mm (0.63 in.)—i.e., the depth of the other beams at the dap area. Bending tests of these beams showed that the dap reduced the load-carrying capacity by almost as much as having the entire beam of reduced depth (Fig. 7).
