Residual Strength and Stiffness of Lumber from Decommissioned Chromated Copper Arsenate–Treated Southern Pine Utility Poles

Cheng Piao
Leslie Groom

©Forest Products Society 2010.
Forest Prod. J. 60(2):166–172.

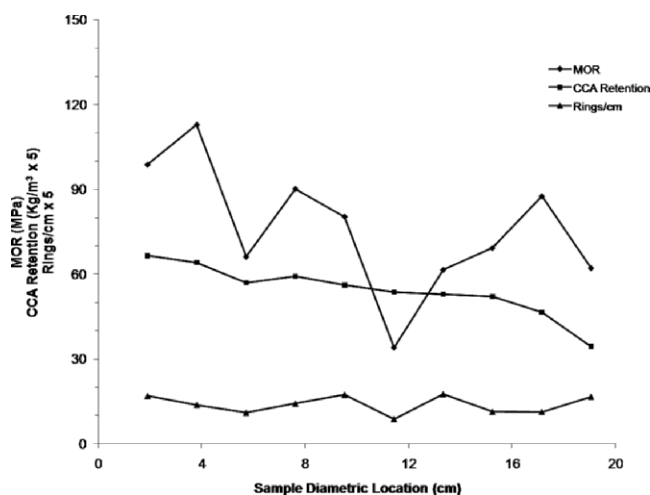
Figure 4.—Modulus of rupture, CCA retention, and ring density (rings per centimeter) of decommissioned utility Pole 1 at 5.6 m below the top (16 y in service).

Barnes (1985) demonstrated that high CCA retention had a detrimental effect on the MOR of southern pine wood. In the present study, the CCA retention of each small clear sample was measured (Figs. 3 and 4). However, because the strength of the small clear samples before CCA treatment was not known, the effect of CCA retention on the MOR of decommissioned utility pole wood was not assessed.
