Residual Strength and Stiffness of Lumber from Decommissioned Chromated Copper Arsenate–Treated Southern Pine Utility Poles

Cheng Piao
Leslie Groom

©Forest Products Society 2010.
Forest Prod. J. 60(2):166–172.

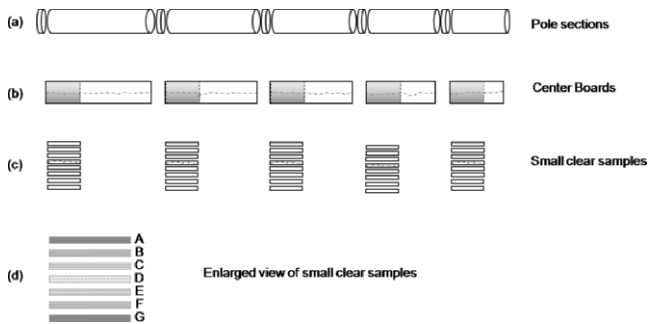
Figure 1 shows a schematic diagram of sampling small clear specimens from a utility pole. Consecutive 2.44-m segments were marked off along the entire length of each pole or pole section. Before segments were cut, the location of each segment from the top of the pole was measured or estimated. After the segments were removed from the pole, each segment was cut into boards, and each board was planed to a final thickness of 19 mm. The center board containing the pith was selected from the boards of each segment (Fig. 1b), and a 41-cm section along the length of

Figure 1.—Diagram of sampling small clear samples from a decommissioned utility pole: (a) pole segments and discs, (b) center boards containing the pith, (c) small clear samples removed from the center boards, and (d) a group of diametric small clear samples obtained from a center board.

each central board was removed from one end. From this section, small clear bending samples were produced by first removing a 3-mm-wide edge along the length of each section and then cutting what remained into 41 cm long by 19-mm square beams (Fig. 1c). These beams were the small clear samples used to measure the bending properties across and along each pole. Before the bending test, beam samples were conditioned in an air-conditioned room for 5 weeks. Each sample was then measured for length, width, thickness, and weight. The specific gravity of each small clear sample was calculated as follows:

It was also found that the samples on pole surface (outer test zone) showed lower MOR compared with the MOR of the adjacent samples (adjacent test zone) on each side of the pole surfaces, regardless of the density and CCA retention of the samples. Figure 1d shows the diametric locations of small clear samples removed from a pole. Sample locations began with a sample from the surface (Sample A), increased inward to the sample in the pith (Sample D), and increased outward to the sample on the other surface (Sample H). Samples A and H were surface samples in the outer test zone, and Sample D was the central sample, containing the pith, in a deep inner test zone. According to a typical behavior of virgin pine logs, Sample A is often stronger than Sample B, because Sample A contains narrower growth rings and more latewood than Sample B. Based on the same rule, Sample H is stronger than Sample G. For decommissioned utility pole wood, the MOR of most samples in the outer test zone (Sample A or H) was lower than the MOR of their adjacent samples (Sample B or G) in the adjacent test zone. This finding was common at most locations along each of the nine older poles (Poles 1 to 9) in sections above the ground line. If a negative sign is assigned to a decrease in MOR from Sample A (or H) to Sample B (or G) and a positive sign is assigned to an increase in MOR from Sample A (or H) to Sample B (or G), then the percentage change of the strength between a sample in the outer test zone and its adjacent sample was calculated using the following formula:

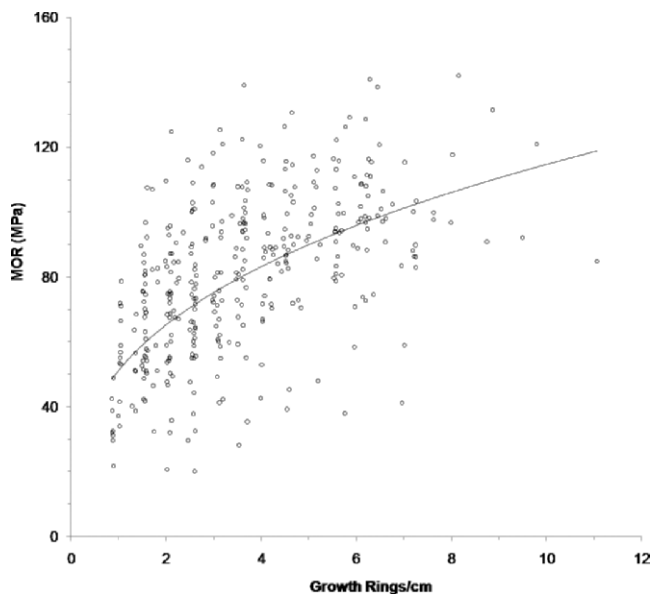
In Figure 2, the MOR values of small clear samples are plotted versus ring density (rings per centimeter). Biblis et al. (2004) reported that the specific gravity and ring density of untreated virgin wood are positively correlated. Because both affect the mechanical properties of wood, a similar relationship was found between the specific gravity and ring density of the decommissioned poles in the present study (Table 2). Of the 11 poles, Poles 1, 7, and 8 showed an average specific gravity of less than 0.55 and were classified as low-density poles. These poles also displayed a low ring density (<3.0 rings per cm) and low strength and stiffness compared with the remaining poles. Pole 8, the largest pole collected in this study, exhibited the lowest specific gravity (0.45), the lowest ring density (1.6 rings per cm), the lowest MOR (57.8 MPa), and the lowest MOE (7.3 × 10³ MPa).

Figure 2.—Relationship between growth rings and strength of wood removed from decommissioned CCA-treated utility poles (Poles 1 to 9).

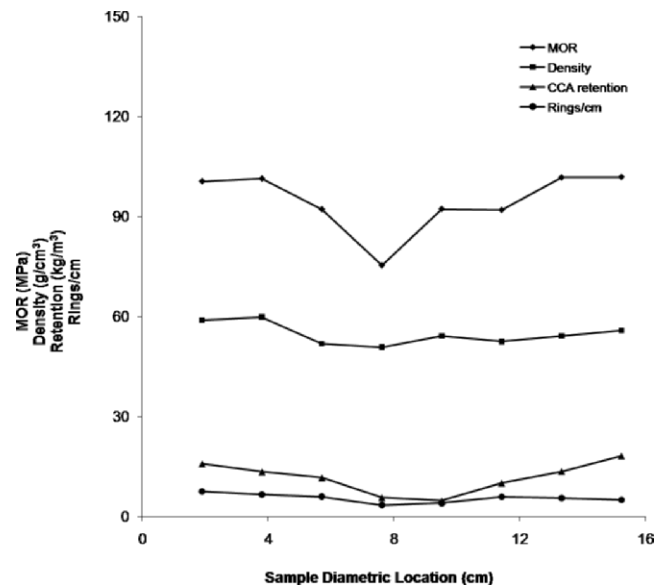
Figure 3.—Modulus of rupture, density, CCA retention, and ring density (rings per centimeter) of diametric samples of decommissioned wood utility Pole 9 (7 y in service).

MOR are expected to increase from the pith to the outside surface. Figure 3 shows a typical variation of MOR, density, CCA retention, and ring density across the diameter of most of the nine older poles (Poles 1 to 9) in this study. MOR and MOE decreased from one surface of a pole to the pith and then increased from the pith to the other surface, following the same pattern as specific gravity and ring density across the diameter of the poles. The MOR and MOE of Poles 3, 7, and 9, for example, were nearly symmetric about their piths at most locations along each of the three poles. The MOR and MOE of Pole 4 were symmetric about its pith at the top two of the four locations that were measured along the pole. A notable exception to this symmetric variation of MOR and MOE was observed on Poles 1, 2, 5, 6, and 8, which were medium- to low-density poles. In these poles, MOR and MOE decreased from one surface of the pole, through the pith, and to the other surface at some locations along each. Figure 4 shows the MOR of the diametric samples of Pole 1 at 5.6 m (full pole length, 12.2 m) below the top of the pole. Also shown in Figure 4 are the CCA retention and ring density of the samples. For comparison purposes, values for CCA retention and ring density in Figure 4 were enlarged by fivefold (i.e., the actual CCA retention and ring density of these samples were five times smaller than the values shown). It can be seen from the figure that both MOR and CCA retention decreased along the diametric direction. The CCA retention of the low-strength side was 6.9 kg/m³, which was lower than the 9.6 kg/m³ required by American Wood-Preservers' Association Standard U1-06 (2006a) for southern pine poles. Therefore, before being decommissioned, one side of Pole 1 had likely decayed and failed to keep the same strength as the other side, which had a CCA retention of 13.3 kg/m³ and likely had not decayed. Similar decreases of MOR and MOE were found on some locations along Poles 2, 5, 7, and 8. In each occurrence of the unbalanced or low MOR and MOE, the CCA retention of the first diametric sample on one or both sides of the diameter was less than 9.6 kg/m³. Leaching and surface degradation might be among the reasons that led to the low CCA retention on the surface zones and decay of these medium- and low-density poles. It is recommended that, when reused as materials for a laminated product, the

Barnes (1985) demonstrated that high CCA retention had a detrimental effect on the MOR of southern pine wood. In the present study, the CCA retention of each small clear sample was measured (Figs. 3 and 4). However, because the strength of the small clear samples before CCA treatment was not known, the effect of CCA retention on the MOR of decommissioned utility pole wood was not assessed.

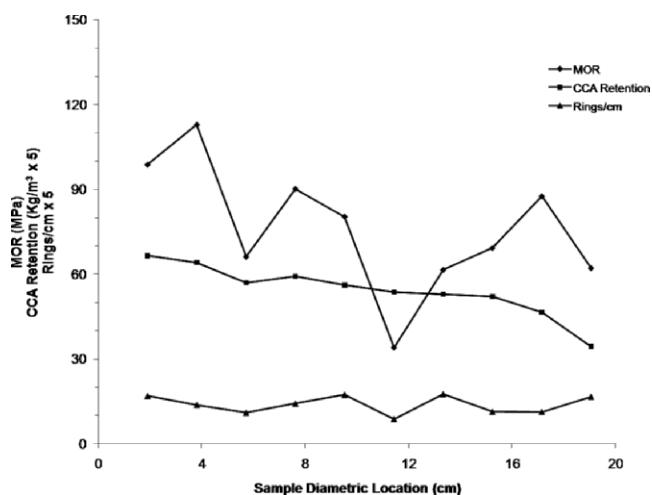
Figure 4.—Modulus of rupture, CCA retention, and ring density (rings per centimeter) of decommissioned utility Pole 1 at 5.6 m below the top (16 y in service).

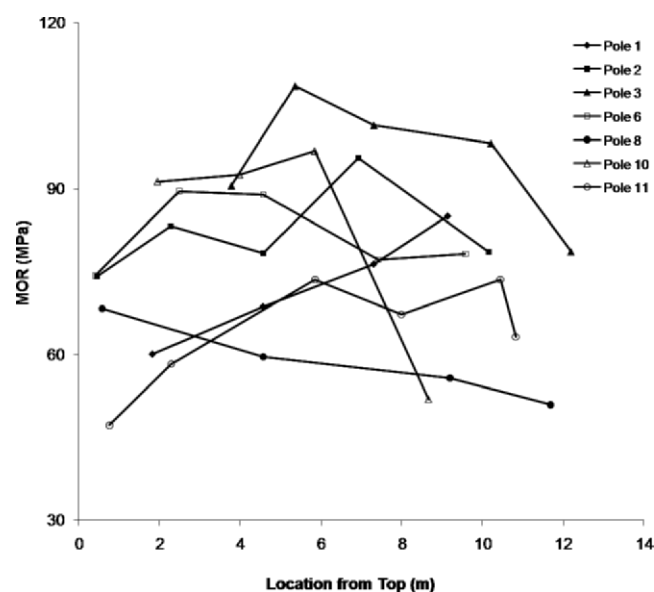
No consistent strength variation pattern was found along the 11 poles (Fig. 5). Pole 8 showed a decreased MOR from the top to about the ground line, while Pole 1 demonstrated a constantly increased MOR from the top to about 9 m from the top (full pole length, 12.2 m). The MOR of the remaining poles varied. One pattern showed MOR increased from the top to about the middle of the poles, then decreased to about the ground lines; the MOR of Poles 2, 3, 7, 10, and 11 belonged to this pattern. Another pattern was that MOR decreased slightly from the top to about the middle of the pole, then increased to the ground line; the MOR of Poles 4, 5, and 9 belonged to this pattern. For poles with a complete underground section, only Poles 4 and 9 demonstrated the greatest MOR at the sections under the ground line; other poles showed that the MOR of the underground wood was weaker than or the weakest compared to the wood from above the ground line. Decay along some of the low-

Figure 5.—Modulus of rupture along decommissioned CCA-treated southern pine utility poles.
